**Structural Specifications of Turkish
Bath's and Collapse Analysis Scenario of
Ismail Bey Bath, Iznik-Turkey**

**Kerimcan Apak
PhD Student
Polytechnic University of Milan
Italy**

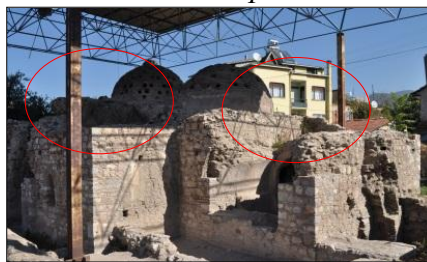
İsmail Bey Bath was located in İznik, ancient Nicaea (Fig 11). In different bibliographies the building date of the İsmail Bey Bath varies. However, the general decision of the building date was in the 15th century. The general interpretation of this building is that it was a private bath and part of a mansion ‘konak’. Today, this building is ruined and half demolished [10].

Figure 11. *İsmail Bey Bath and its Collapsed Parts, İznik*

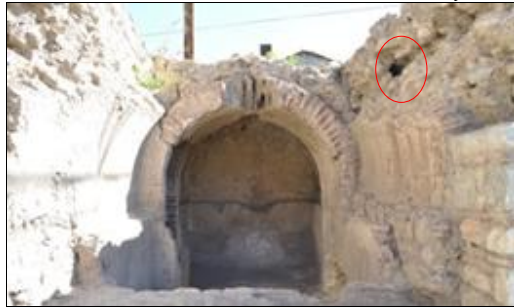
Figure 13: *Wall Section-Timber Beam Hole, İsmail Bey Bath, İznik*

Timber tie beams were used horizontally inside of the walls for providing strength for the lateral forces. The square voids inside the walls remained after the dissolution of the timber beam (Fig 13, 15).

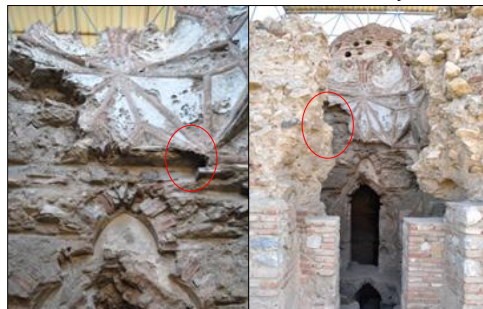
Figure 15. *Wall Section-Timber Beam Hole, İsmail Bey Bath, İznik*

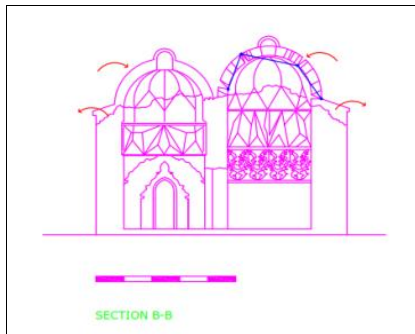
The walls could be damaged through environmental effects as well as seismic forces. Therefore, binding capacity of the mortar with stones was decreased on the wall. The round dome base implemented pressure to the upper side of the wall and the top of the wall could not resist this pressure that was coming from the dome base round and finally it collapsed (Fig 19) [7, 8, 9].

Figure 19. *Schematic Collapse Behavior of Masonry Wall and the Dome in İsmail Bey Bath, İznik*

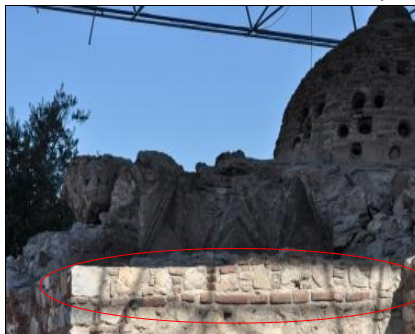
Afterwards, the dome collapsed. And now the existing parts of the dome can be seen on the structure, as well the new reconstructed parts of the wall (Fig 20).

Figure 20. *Collapsed Dome and Reconstructed Wall, İsmail Bey Bath, İznik*

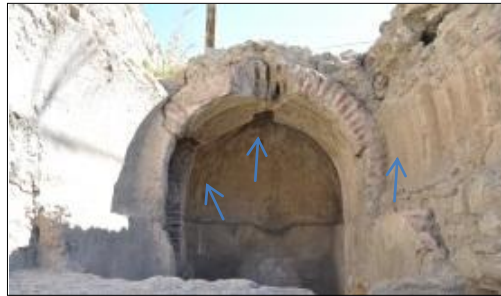
A big part of the vault collapsed. The crack patterns could be seen under the vault structure (Fig 21). These crack patterns guided the collapse mechanism of the vault (Fig 22). The environmental effects include seismic activity and degradation of the construction materials that could be the reason for the collapsing of the vault structure.

Figure 21. *Cracks Under the Vault*

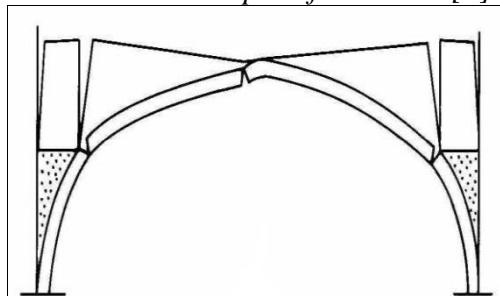
Figure 22. *Schematic Structural Collapse of the Vault [8]*

The brick pattern layout on the masonry wall patterns could not affect this collapse. However, timber ties could be one of the reasons for this collapse. The masonry walls were stabled and tied by the timber tie beams. Decay of the timber beams would leave the upper part of the masonry walls and free them to slope inside the vault. The higher load which passed the carrying limits of the vault could be the reason for the start of the collapse mechanism of the structure (Fig 22), [7, 8, 9].
