**Damage Analysis on a Broken Crank
Shaft of a High Power Pump**

Peter Böhm

University of Applied Sciences Trier

Damage Analysis on a Broken Crank Shaft of a High Power Pump

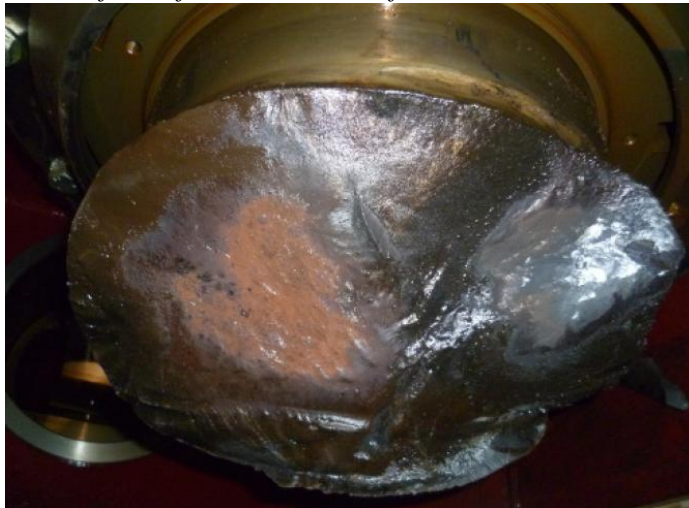
Figure 1. *Crack Surface of the Broken Shaft*

Fortunately in the present case there was no human victim which had to be inspected. We had to deal with a broken crank shaft of a high power tube-membrane-piston pump, figure 1. Anyhow the shaft had a weight of over 2,5 tons, a length of 3,5 meter and a diameter of 560 mm. The shaft rotated with 30 Hz, so enormous forces took effect on the shaft. The production of the shaft was in 2006 and afterwards delivered to China, used in coal-mines. After four years of use the critical damage occurred. Human loss could be precluded due to the construction of the pump. The economical trouble and in particular a possible loss of public image forces a producer to find out the reason why the system crashed. After the crash the broken parts of the shaft were transported back to the German producer. Before that the splotchy crack surfaces had been cleaned and the two parts including the crack surfaces were cut of, not to send the whole shaft on the way back. The constructional calculations flanked by a Finite Element Analysis had shown that the theoretical maximum load of about 205 MPa due to bending fatigue strength has not been reached. Therefore a failure in constructional calculations could not be the reason for the crash. First of all the Analyst of the damage had to collect all information. Asking the operator of the pump he noticed absolutely no striking features before appearance of the crash. An exact number of cycles was unknown. So the we had to check at first the material data. The crank shaft was produced of casting steel – 1.7221, G26CrMo4, heat treating level QT 1. The acceptance test certificate of the casting house attested all mechanical conditions, the chemical analysis as well as the results of the Ultrasonic Testing and the Magnetic

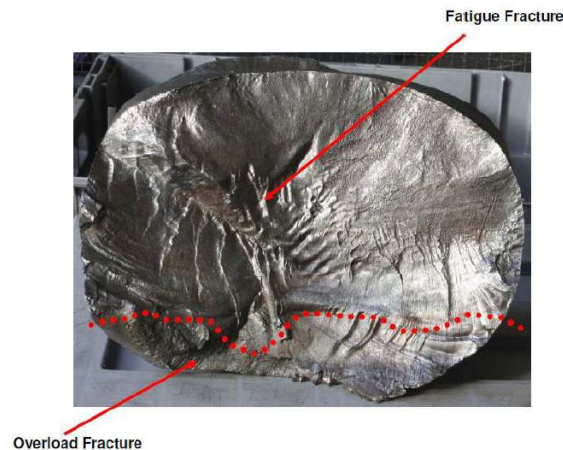
Figure 2. *Overview Screen of the Crack Surface*

First visual testing inspections showed the tendency due to a fatigue crack, which was underlined by finding numerous lines of rest. The part of the fatigue fracture zone was up to 90 % of the whole crack surface. Therefore the nominal stress was assumable low. The crack started from the top, figure 2, the relatively marginal zone of the overload fracture can be seen at the bottom. The crack went through the cross sectional area under unidirectional bending force. The area of fracture was hammered by the cyclic opening and closing of the growing crack. Therefore important advises had been destroyed. So we had been forced to comprehend first the test results of the casting house if the material data of the G 26CrMo4 are correct. For it some parts of the broken shaft had been extracted and test specimen for the tensile test had been produced. Overall the casting house sent us test specimen of the same material which went through the same heat treatment like the original material for comparing results. The results pointed out that all data coming from the tensile

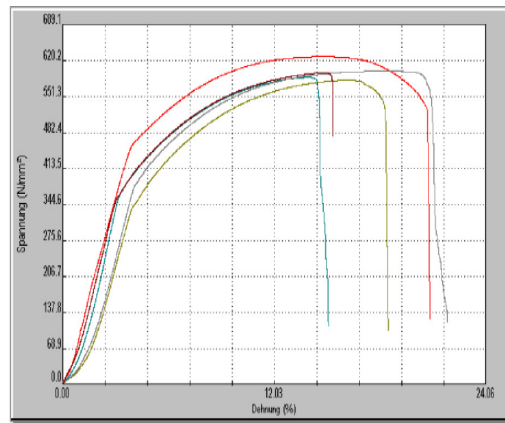
test corresponds to the data for casting steel according to DIN EN 10293, heat treating level QT1 for a thickness over 250 mm, figure 3. The results coming from the new produced casting steel showed higher values in tensile strength, data of elongation were nearly the same. Talking to the casting house to find out the reason for the difference of the tensile test results – although the requirements according to the standard had been fulfilled in both cases – we recovered the main cause. The casting house cut out the specimen directly from the surface. Our specimen had been cut out from the internal part of the broken shaft. So in our examinations we performed the tests with specimen having a ferritic-perlitic microstructure, the casting house with specimen having a bainitic microstructure. The evaluation of the fracture areas of the tensile specimen showed some silvery spots. By help of a stereo microscope we detected in the centre of the silvery spots in each case a blowhole, figure 4.

Figure 3. Tensile Test Diagram

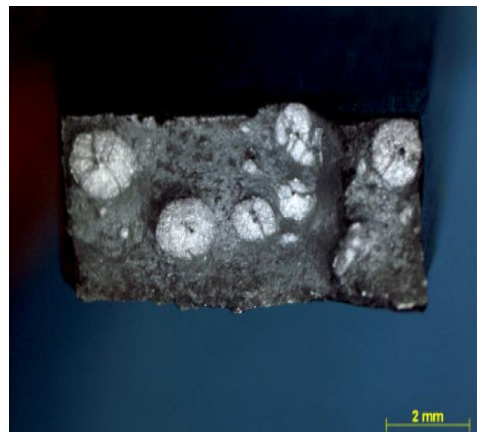
Figure 4. Fracture Area of One of the Flat bar Tension Specimen

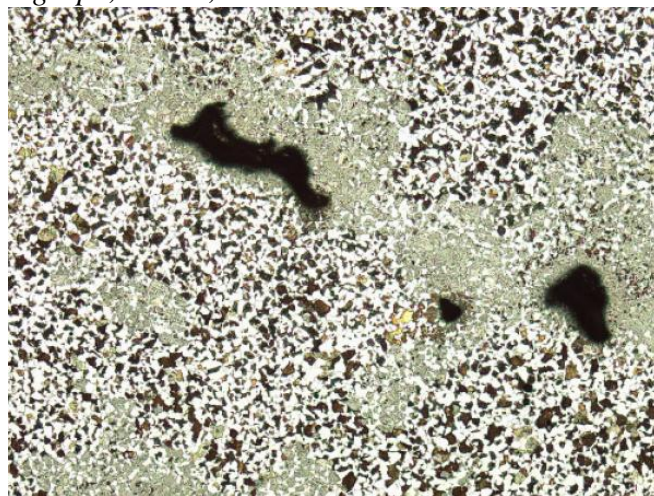
investigations. Within a ferritic-perlitic basic structure one can recognize the blowholes surrounded by segregations containing phosphoric, sulphuric and carbide accumulations. The perlitic structure was extremely small banded (portions of sorbite and troostite) and contained some relics of bainitic areas. The partially rodded bainitic structure also contains some areas of Widmannstatten patterns, figure 5. The ferritic percentage in the boundary area of the shaft was much lower compared to the core area. In consequence of the higher ferritic and lower bainitic level of the core of the shaft due to strength was lower, the boundary area due to strength higher. More over it was stated that more blowholes surrounded by segregations can be found in the core. Also examinations performed by notch impact test produce results had been acceptable with regard to the standard.

Figure 4. *Micrograph, etched, 50:1*

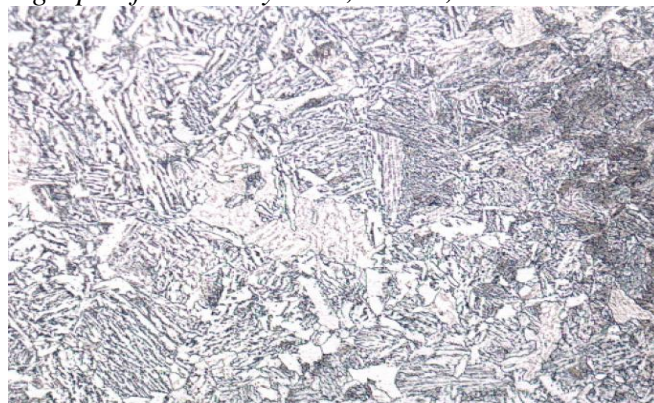
Figure 5. *Micrograph of Boundary Area, etched, 500:1*

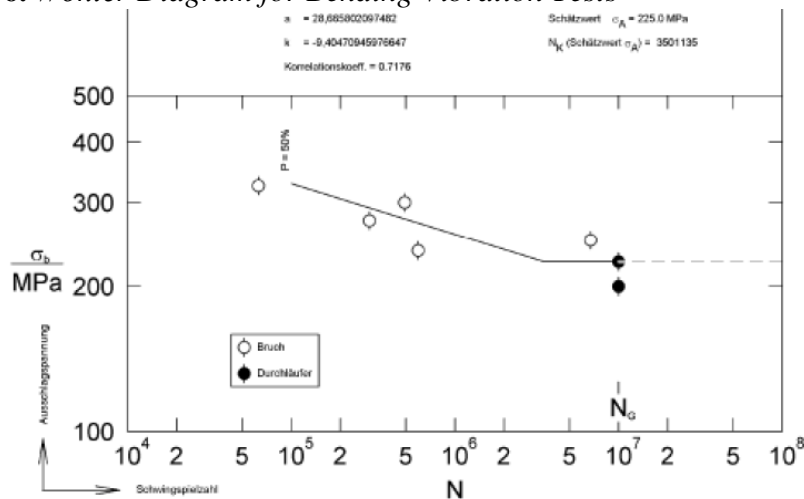
stress was about 225 MPa, figure 6. The Finite Element Analysis calculated with about 100 MPa at its maximum. One remarkable fact was: no respectively a low number of segregations had been found within the specimen. It seemed to be that segregations in the core of the specimen had no influence with regard to the strength of the material. But otherwise we found one specimen which failed at a low amplitude of less than 100 MPa. And in that case we detected a segregation directly under the surface within the fracture area. The output was clear and is manifested in many publications. Segregations directly under the surface have a strong influence on the bending fatigue strength. So we started again to examine the fracture area of the shaft with regard to some imponderabilia. And fortunately we found a location directly under the surface, figure 7. So we cut out this spot and put it under scanning beam electron microscope.

Figure 6. *Wöhler Diagram for Bending Vibration Tests*

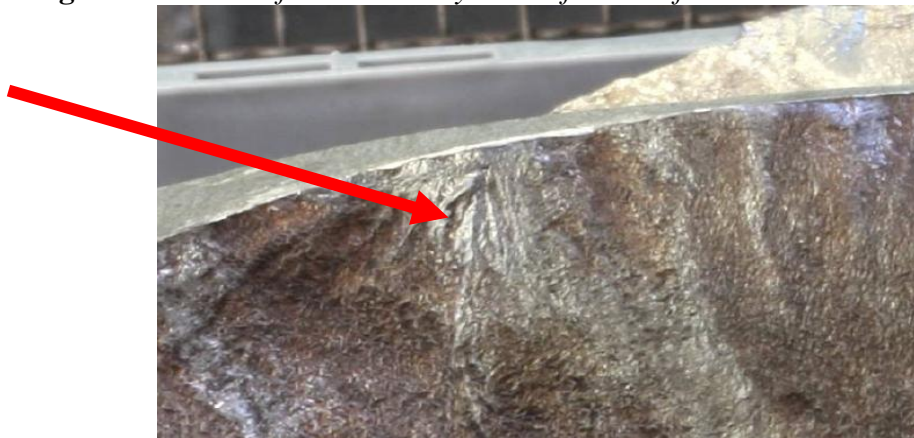
Figure 7. *Section of the Boundary Area of the Shaft*

surface of the specimen we found the malefactor – a micro blowhole which was situated 2 mm under the surface having a dimension of 1 mm. That micro blowhole could be allocated to the spot which was pointed out in figure 7 by the arrow. So we assume that effectively the crack started at the micro blowhole, propagated to the surface of the shaft and grew further until the shaft crashed. Furthermore we found some polishing tracks which caused some micro notches on the surface. In combination with the micro blowhole under the surface it was only a matter of time until the crack started its propagation.

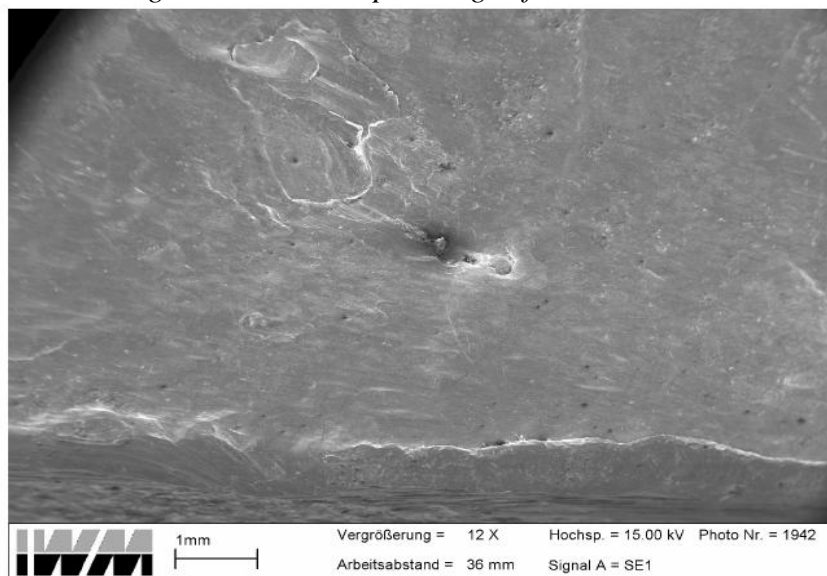
Figure 8. *Scanning Beam Microscopic Image of a Blowhole near the Surface*

The surface quality factor of a component under operational conditions is of enormous importance for fatigue behaviour. Duration of life of technical constructions can be prolonged by avoiding small radius of curvature and treatment of the surface. Within the existing case it was a matter of fatigue breakage showing a minor ratio of overload fracture. Finally not the mechanical-technological properties determined the crash of the shaft. On the one hand the surface treatment - the incorrect polishing - , on the other hand blowholes directly under the surface lead to initiate crack start. Starting from the blowhole the crack propagated radial, also in the direction of the component surface. From that point of time the crack propagation and finally the overload breakage was only a question of time correspondent to the number of cycles of flexural fatigue stress. To validate these results more vibration fatigue tests had been performed having blowholes near or directly on the surface. These specimen failed at a relatively low number of stress cycles. The extracted experiences coming out of the damage analysis had been integrated in the production of the next generation of pump shafts. First the polishing of the surfaces was optimized by creating new quality procedures, finally the application of high technology ultrasonic methods for the detection of small blowholes under the surface was implemented.
