**A Study on Ankara Citadel Area**

In this paper, a study on Ankara citadel area has been performed. Ankara has a special value in the modern State of The Republic of Turkey due to being the capital city of the country. Thereby, Ankara citadel area is a distinctive place which shapes the structural development of Turkey's capital city, which it is also a situation that the structural development of Ankara as the capital city acts as a role model for the other cities of the modern Republic established after Ottoman Empire. Therefore, due to the fact that the special historical significance which Ankara and its citadel area have is the main reason for the selection of Ankara citadel area as a study area. In this regard, a specific public square on the citadel area and the structures existing on the square examined considering public square, structures and relationship between them separately. While examining the study area, the usage relationships of the public square and the structures were evaluated. Additionally, the indoor parts of the some structures were also examined. While doing this, the situations of the study area in the year 2010 and the year 2014 are compared considerin

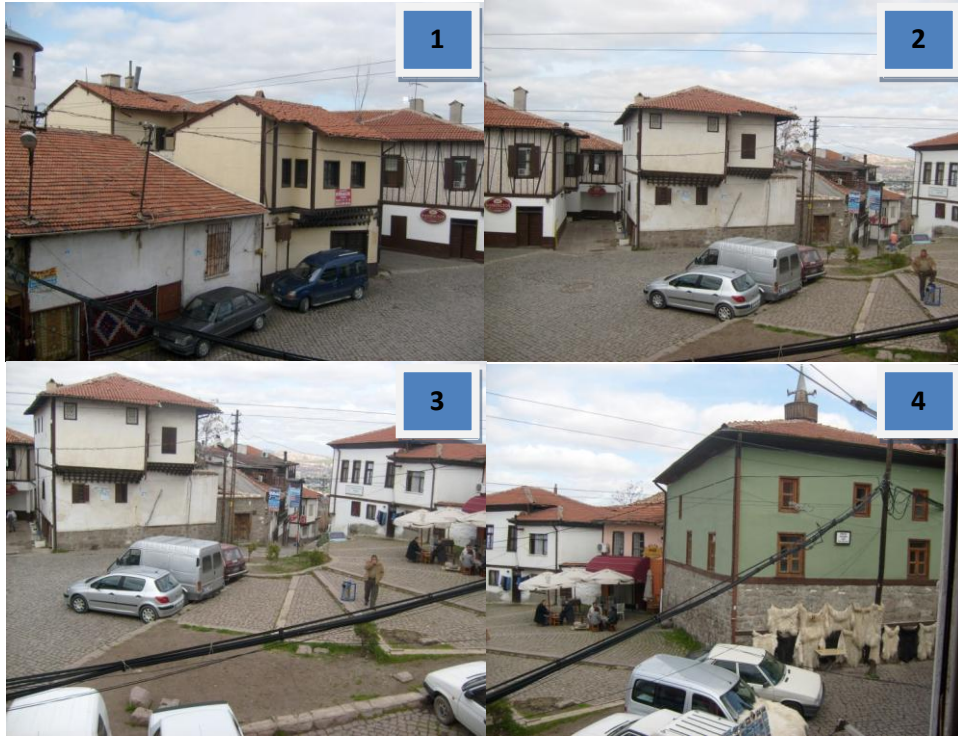
**Figure 1.** *The Study Area(2010)*

The area that is studied (Kaleiçi, Doyran Street) is relatively smooth considering topographical conditions comparing with the other sites of the citadel area. By function, it is a tourist-oriented small square that enables tourists to buy from nearby shops that sell carpets, jewellery and antiqua stuff etc. This small tourist-oriented square also includes a small café and a restaurant (Figure 1.).

Considering some infrastructural elements, the electric cables that can be easily seen in photographs 3 and 4 highly (in Figure 1.) bother the eyes. This appearance of those electric cables is not appropriate for the maintenance and sustainability of the cultural aspects of this square and should be immediately corrected in a proper way. This situation seems to be corrected in today (Figure 2.).

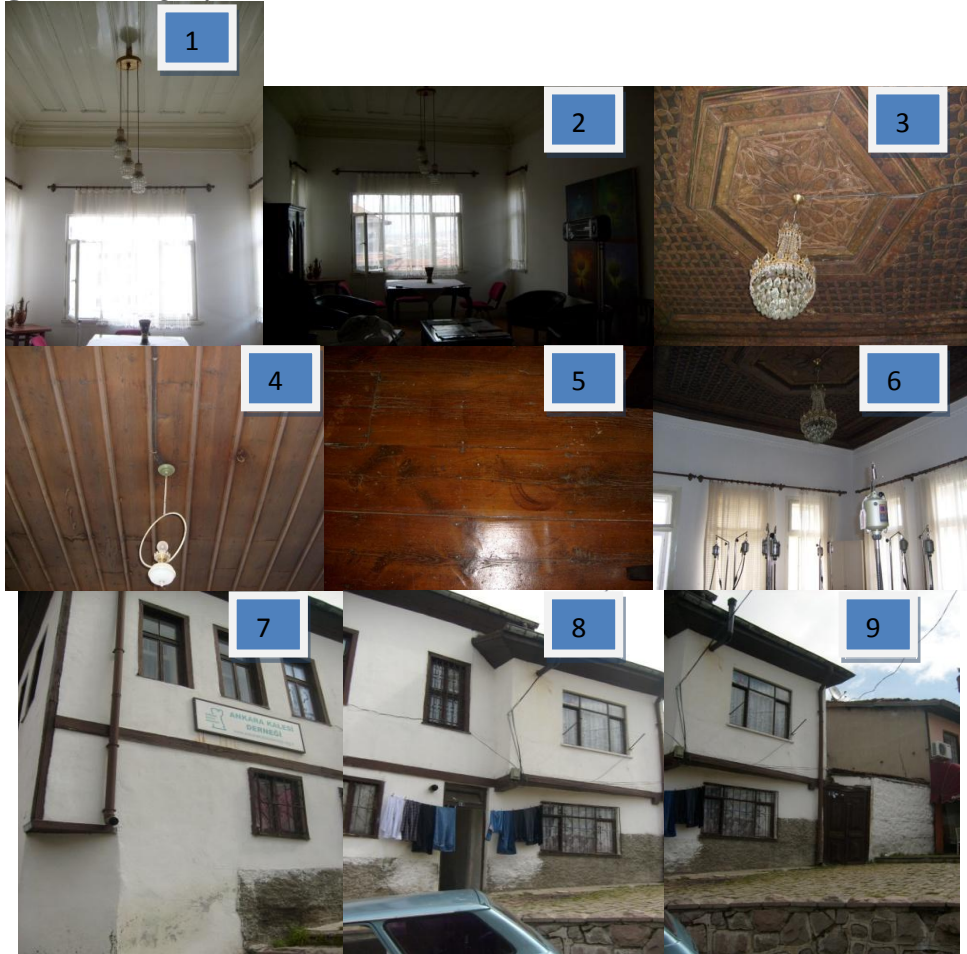
**Figure 3.** Images from the 1<sup>st</sup> case (2010)

According to Ankara Kalesi Derneği which exists at the second floor of the structure, this historical building is also known as Sabuncuoğlu Konağı and has two storeys within a single storey later added part. As you can see in the Figure 3., the interior structures of the building are restored by confirming the authenticity of the materials and ornaments as it exists in the 3<sup>rd</sup> photograph above. The ceiling was restored in the 1<sup>st</sup>, 2<sup>nd</sup> and 3<sup>rd</sup> photographs. However, ceiling which is in the 3<sup>rd</sup> photograph is remained still as it was before without restoration also includes Bohemia flint for lighting purposes. Also, the floor is remained its original characteristic of material but renewed its varnish later.

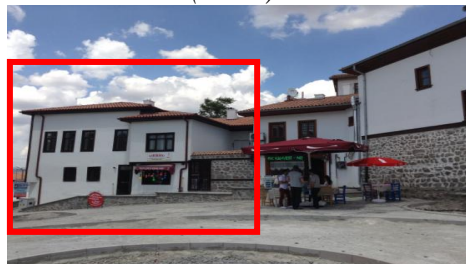
**Figure 4.** Images from the 1<sup>st</sup> Case (2014)

This structure as a whole includes two different functions. The first one is that the second floor of the structure is used as Ankara Kalesi Derneği and the second one is that the ground floor is used for the residential purposes by a family. Additionally, this building has no specific garden. As it can be seen from the 9<sup>th</sup> photograph, the single storey part is seem to be added later. Paint of the building is seem to be renewed and under the paintings of the wall, there seems the original building material of the structure that gives this building an “authenticity and historicity”. This situation has been intensified by another restoration project as seen in the Figure 4, representing the year of 2014.

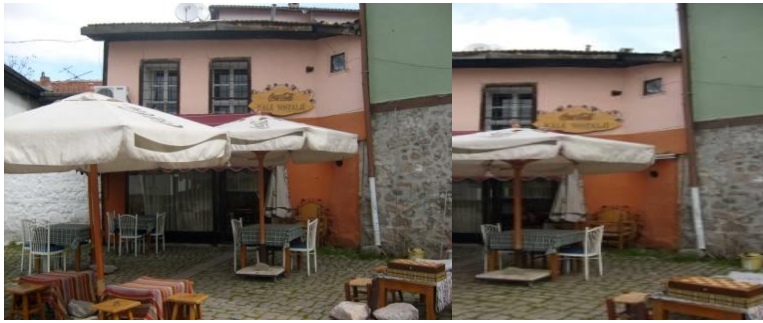
As it is indicated in the Figure 5., the structure involves two storeys. Its painting is seemed to be renewed so many times and looks like clean. The ground floor of the structure is used for the commercial uses. A café which is named “Kale Nostalji” exists in order to provide the tourist attention to the

studied square and according to the café owner; the second floor is used for the residential purposes. Coming to the interior aspects of the café and café owner, inside of the café has subjected to the restoration process which caused a bit of disappearance of the structure's authenticity and historicity. Actually, considering within its whole design, this structure is not seemed to a “wholly authentic” manner. In the Figure 6., the structure has subject to a restoration process which has caused the loss of its specific façade color which separate the structure from the other buildings .

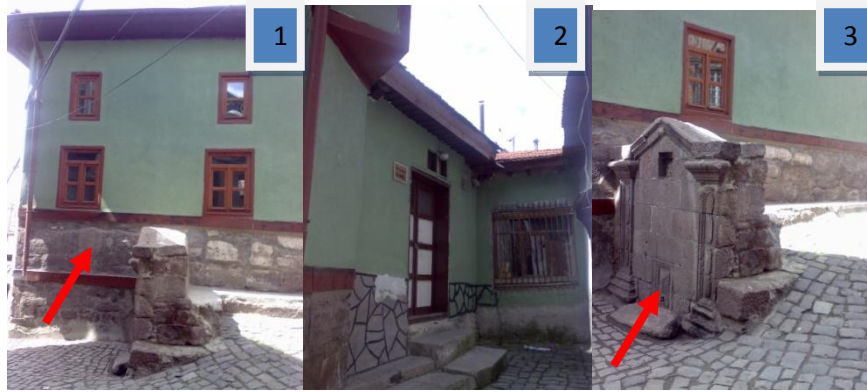
**Figure 7.** *The Images from 3<sup>rd</sup> Case (2010)*

This structure above illustrated in the Figure 7 and Figure 8. has religious importance in this historical citadel area and called as Ramazan Şemsettin Mosque. It was built in 17<sup>th</sup> century. Additionally, its door as it is indicated in the 2<sup>nd</sup> photograph and lower stone pavement (indicated within the red arrow in the 1<sup>st</sup> photograph) is original, namely authentic. Moreover, its painting was renewed in the previous years. In addition to these, there exists an interesting drinking fountain (indicated within the red arrow in the 3<sup>rd</sup> photograph) yet it is not flowing shows its historicity aspects in its building materials. This drinking fountain is not seemed to be restored and this situation gives it more “authentic and historic manner” by its aesthetical appearance. Additionally, this mosque does not have any specific garden or an assembly for the community who come to the mosque for the religious purposes. In addition to these this mosque gives an identity to the square by creating aspects of being a “landmark”. In the Figure 8., the current situation of the mosque could be observed. The most

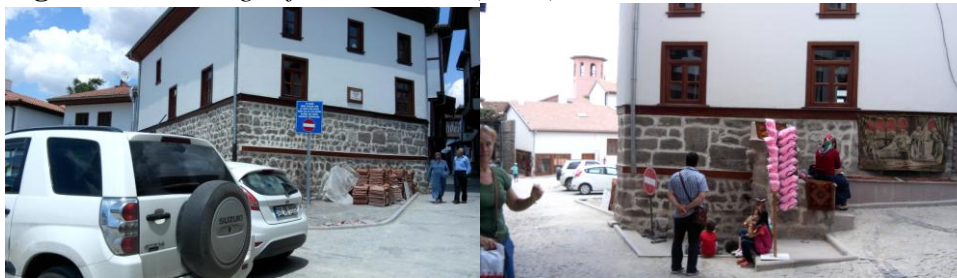
**Figure 8.** *The images from 3<sup>rd</sup> Case (2014)*

striking issue in the figure is that the mosque has lost its authentic value by losing its original scene.

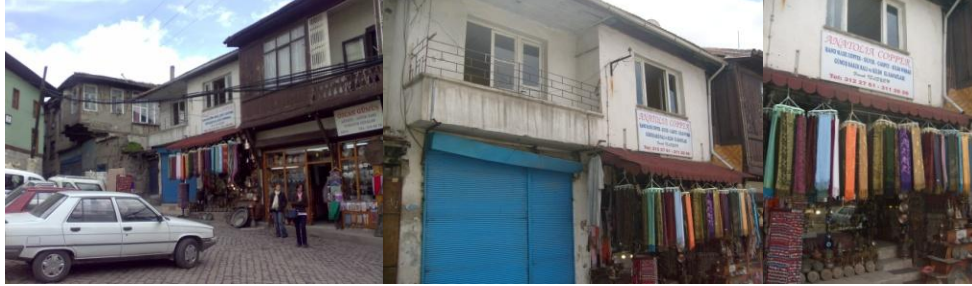
**Figure 9.** *Images from the 4<sup>th</sup> Case (2010)*

In this case, it is seen that this structure consists of two storeys (Figure 9.). The ground floor consists two commercial units one of them is not used and the other ones is used as a shop that contain touristic stuff. The second floor is not used for either commercial or residential purposes. This building seems have no authentic and historical value even if it was in the previous ten years. Because its surface is seemed to be deteriorated (and re-painted, the original material is not realized beneath it), its windows are not authentic representing the modern understanding of architectural aspects. It could be stated that it lost completely its authenticity and historicity. In the Figure 10., the current view of the structure is seen. Within the restoration process, it is observed that the structure was liken to the other structures in the studied square.

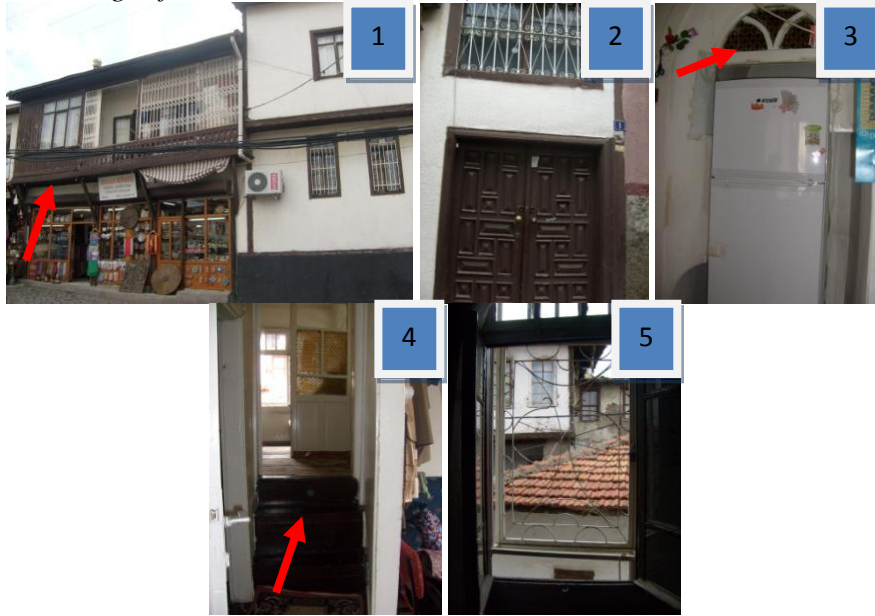
**Figure 11.** Images from the 5<sup>th</sup> Case (2010)

In this case, the structure has two storeys (Figure 11.). The left-ground floor is used for commercial purposes and rest of them of the structure is used for the residential purposes by a family. This structure has considerable authentic and historical importance, considering the material used for its facades, its windows, doors and the ornaments and characteristics of its interior design. In the 1<sup>st</sup> photograph, the colonnade that is indicated with the arrow is seemed to be added later for the fortification yet depending on its authentic characteristics. According to the households of this structure, the balcony and this colonnade built later. In addition to these, the main door of the structure (in photograph 2) is later painted but its original characteristics are protected, so it's an authentic part. Additionally, coming to the interior parts of the building (photographs 3,4 and 5), the ornament and its indent part which the refrigerator put in this example constitute an authentic and historic environment. Additionally,

the steps showed by red arrow in the photograph 4 are also in its original characteristics but it is later varnished and painted. Moreover, window grate in the 5<sup>th</sup> photograph is also original, that is authentic and seems highly historical. In the inner part of the structure which a family lives in, the floor and the ceiling has undergone the repair but depending on its original characteristics considering the material and shape which are used for their construction. In Figure 12., the current situation of the structure is seen. As in the other examples, single type of restoration features have been implemented considering this structure, too. It could be observed that the left-top side of the façade has lost its originality.

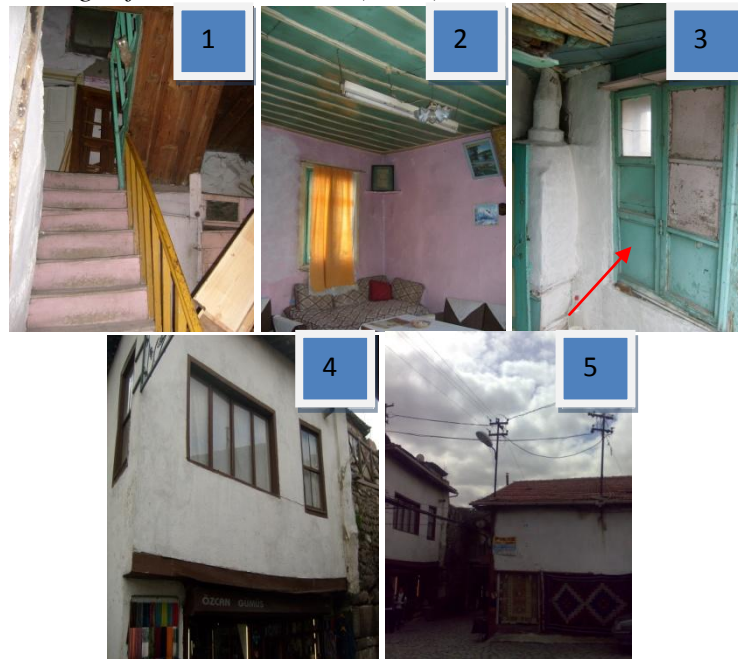
**Figure 13.** Images from the 6<sup>th</sup> Case (2010)

In this case, the building has two storeys (Figure 13.). The ground floor is used for commercial purposes and the second floor is used for residential purposes. The structure (shown in the 4<sup>th</sup> photograph and 5<sup>th</sup> photograph with

red arrow) has its own authenticity however it has poor material structure because of the lapse of time. Actually, this squalidity shows itself clearly when coming to the interior part of the structure apart from its characteristics of facades. Looking at the 1<sup>st</sup>, 2<sup>nd</sup> and 3<sup>rd</sup> photographs, it can be easily seen that it still has its own authenticity and historicity. However, the squalidity disappears the authenticity of the structure. As it is shown in the 2<sup>nd</sup> photograph, the ceiling is original, but according to the householder it has undergone the process of painting and varnishing depending the protection of its original characteristics. Additionally, the window-like structure in the 3<sup>rd</sup> photograph (emphasized with red arrow) is also authentic comparing the modern values of today. However as it can be easily understood from the photographs, both the outside and inside of the structure is lack of care and this situation causes the building's deterioration. The Figure 14. shows the current situation of the structure. It seems similar to its previously restored situation.

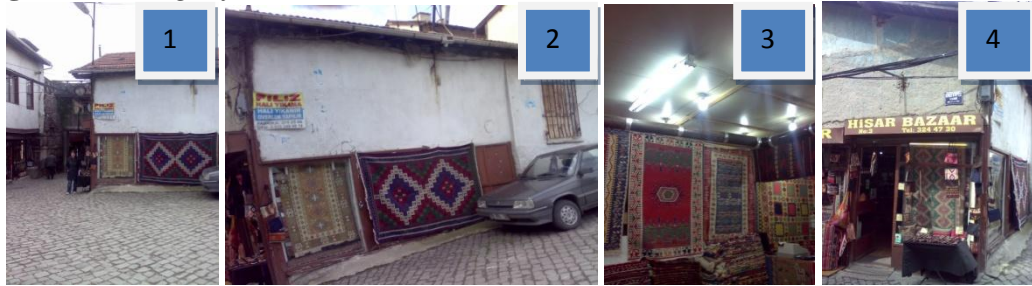
**Figure 15.** *Images from the 7th Case (2010)*

In this case again, the building consists of two storeys (Figure 8.). The first, ground floor is used for commercial purposes (photograph 4) again and the second floor is used as residential. This building is seemed to be lost its historicity and authenticity. Considering its building material, painting and the sphere of its windows etc., it gives no historical sensivity to the observer. As it can be seen from the 3<sup>rd</sup> photograph, in the shop, the ceiling was completely changed instead of protecting its authentic, original structure. Briefly, this structure seems totally lost its historical and authentical elements. Maybe its

window structure and painting aspects could be changed in order to provide the recoverance of its historical aspects. The structure does not contain any specific garden or courtyard. In the Figure 16, the current structure of the building is seen. It is understood that the current restoration process has fixes some deterioration on the façade.

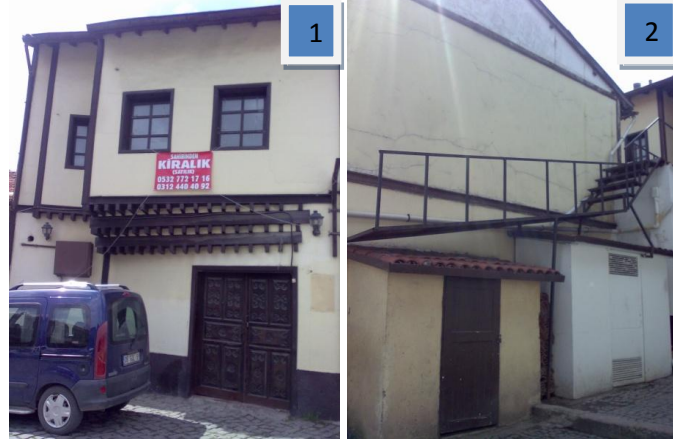
**Figure 17.** Images from the 8<sup>th</sup> Case (2010)

This two-storey house has no commercial activities like in the previous examples (Figure 17.). Instead it is now empty and on hire. Looking at the facades of this building, one can easily realize that it is highly authentic. Its doors and windows have been restored depending on its original characteristics. Its painting and polishment have been properly made in order to protect the structure's own aesthetical, historical and authentional aspects. Especially its colonnade shows the elements of its authenticity. Looking at the 2<sup>nd</sup> photograph, there is a small part has been laterly added is realized immediately. This part is used for the storage purposes. On the other hand, again in the 2<sup>nd</sup> photograph, it can be seen that there are steps. These steps have been laterly added to the structure. In the Figure 18., the current situation of the structure is seen. It is realized that the current restoration process have not had a significant effect in the change of the façade. Only some fixes and the change of color is observed on it.

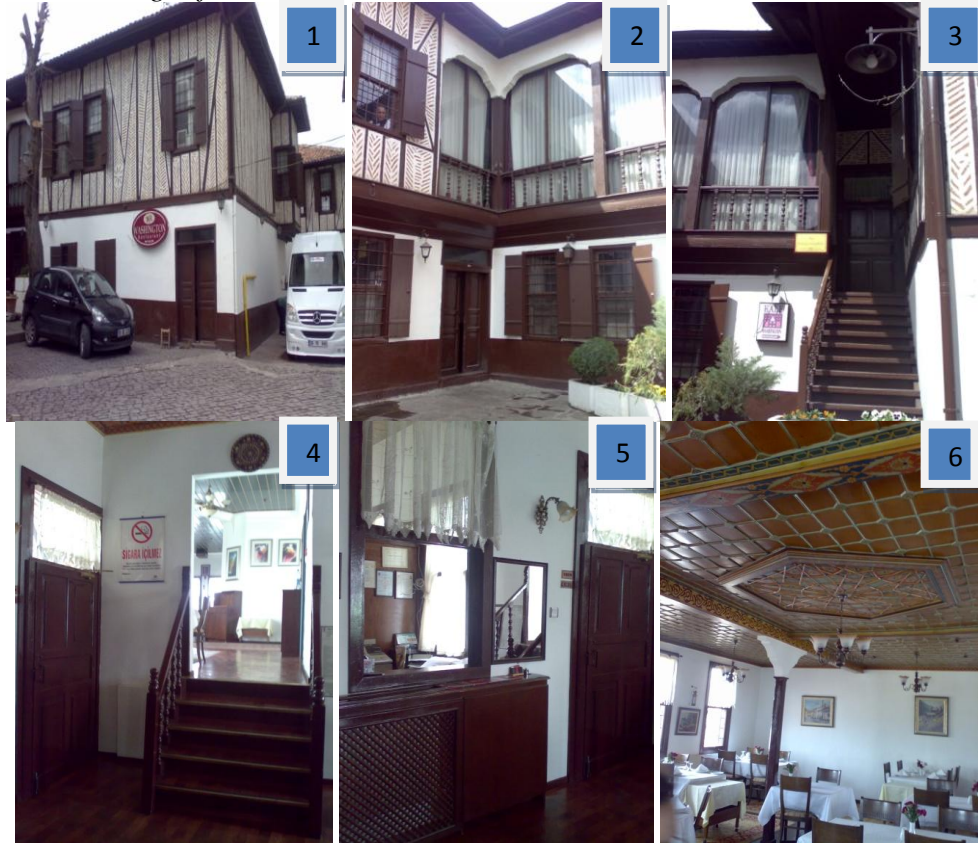
**Figure 19.** *Images from the 9<sup>th</sup> Case*

This case is actually really interesting case considering the authenticity and the historicity of a historical building (Figure 19.). This building is used as only restaurant but in the previous ten years, it was used for the residential purposes and it was known as the mansion of the Sipahioğlu family. Before the function of as a restaurant, this structure has undergone repairs and these repairments were over in 1993. Since 1993, this building has been used as a restaurant which is called as Washington Restaurant. According to the owner of the

restaurant, this building has stood for 300 or 400 years that is an actually very long period. Within the repairment movement that was over in 1993, the interior and the exterior structure of the building has been restored depending on its original structure, its own authenticity. As you can see from the all photographs that the restoration process has made the building has its own authenticity. Within its wall paint, windows and doors, it gives for an observer to full sense of history and authenticity. Especially in its interior design which is represented by the photographs of 4,5 and 6, one can understand that its interior originality has been protected in addition to its external facades. In the Figure 20., the current situation of the structure is illustrated. As it could be seen in the Figure 20., new restoration process has not been implemented to this structure.

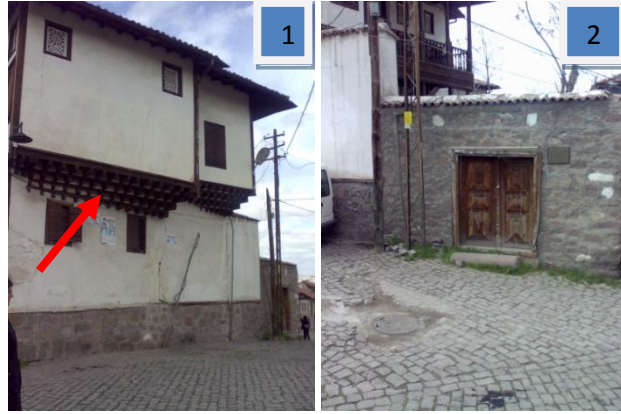
**Figure 21.** Images from the 10<sup>th</sup> Case (2010)

This building is two-storey building and this is another case which could be find authenticity and historicity in the sense of building's materials (Figure 21.). At first glance, this building gives an observer to a kind of authentic and historic sensitivity. The observer can feel inside when he looks at this building. As it could be understood from the photographs that the building has experienced a restoration process. It is seemed that the restoration process has been protected the building's original structure, its authenticity. In the 1<sup>st</sup>

photograph, the colonnade of the building is well protected by the restoration process and as it can be easily seen from the 2<sup>nd</sup> photograph that the door outside of the building is also in its own authenticity means that the original characteristics of the door (materials used in its construction ) has been maintained properly. In addition to these this building was used by Türkiye Foto Muhabirleri Derneği. However, in the previous years, this building has transferred to the municipality and waiting for the operation. In the Figure 22., the current situation of the structure is seen. It is seen from the figure that the current restoration process has contributed to some fixes on the façade.

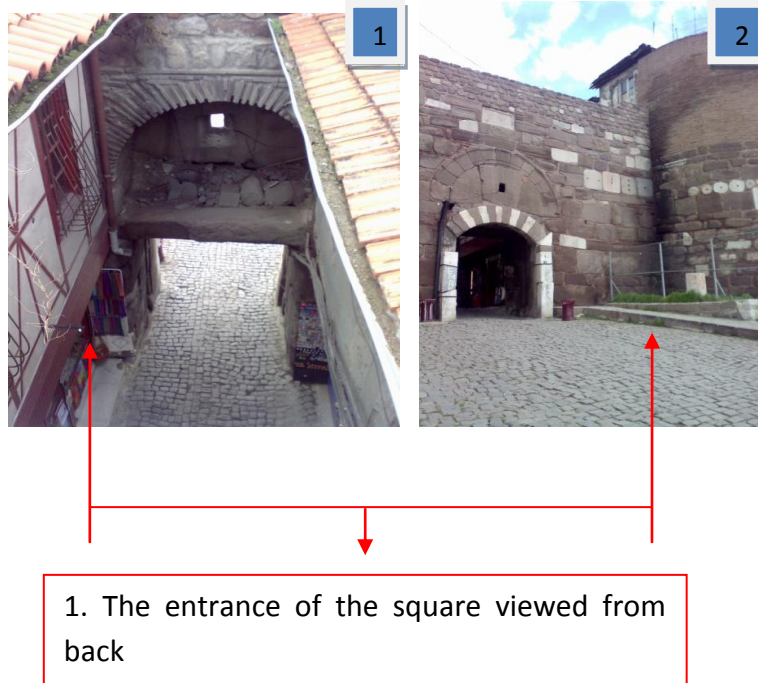
**Figure 23.** *The Entrances to the Study Area from Different Perspectives (front and back)*

As it could be seen from the photographs above indicated in Figure 23., the entrances of the square is also gives an identity of history. In this square, people could feel themselves in a historical and well-defined space. The entrance clearly shows its authenticity in material and design at first glance. Thus, it could be stated that even the entrance of this public square and the square itself (within its buildings) show its authenticity in the period of its “historical stratigraphy”. As a whole the square gives an understanding of “the living in the past” because of its historical anticipation. Additionally, many of its buildings have been restored and their historical values have been maintained to today. Within this maintenance of the value of these buildings, they are also evaluated considering the economical and social aspects of the
