CIV2013-0785

**Geotechnical Investigation of Ban
Koum Dam Site, LPDR-Thailand
Borders**

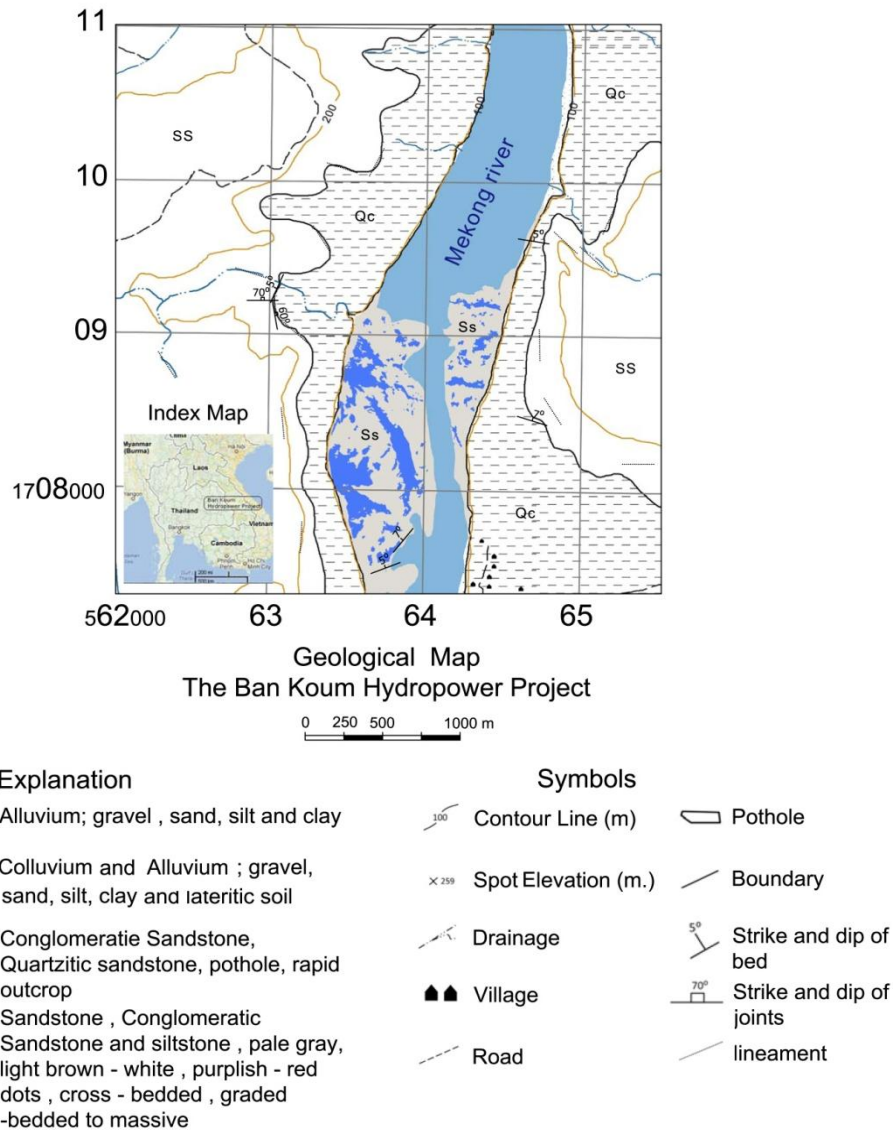
Figure 2. *Geologic Map of the Study Area*

Geology; Geologic map of the the Ban Koum Hydropower Project was shown in Fig.2. Sandstone is mostly common found in the dam site which supported by the 1:1,000,000 geological map of Kampuchea, Laos and Vietnam (General Department of Geology, 1988). There were 4 rock units covered the study area which described as the following.

SS rock unit covered the mountainous areas at the right and left abutments, was depicted as sandstone, conglomeratic sandstone and siltstone; pale gray, light brown to white, purplish - red dots, cross - bedded, graded - bedded to massive rock. The rock bedding is gentle dip (about 5° - 15°) through northwest - west with the dip direction of 290° - 315°. The majority joint was in same direction of Mekong River, 350° - 30° with vertical dip. Minority joints showed the values of strike and dip as 250° - 280° / 5° - 10° NW-N, 120° - 150° / 60° - 80° SW and 25° - 40° / 70° - 85°. Schmidt rebound number of sandstone showed as 40 - 45 numbers which could be estimated the uniaxial compressive strength of sandstone as 40-50 MPa. Sand grains of sandstone were poorly sorted with was moderate to well cemented. Siltstone was moderately to highly weathered, and showed the low to moderate degree of hardness compared with sandstone. Rock mass presented competent and incompetent bedding. Weathering condition in rock mass was slightly to moderately degree of weathering. Joint spacing of the rock mass was varied from 10 cm to 10 m. Rock mass was highly jointed to massive or large block rock. Open joint and clay filled joint were found at the rock surface. The tight joint and 1-5 mm opened joint were typically found. Water seepage and spring have not been found in the rock mass at the project area. Soi Sawan Waterfall was recognized and was located far 2.5 km from the center line of dam in North West. In general, rock mass rating value showed good condition. The shear strength properties of the rock masses, estimated by RMR, presented the internal friction angle and cohesion as 35° - 45° and 300 - 400 kPa.

Ss rock unit covered the rapid at the Mekong River. It comprised of conglomeratic sandstone and quartzitic sandstone, white to light brown, various sizes of the pot holes on rock surface. Strike and dip of the sandstone bedding was 175° - 195° / 5° - 10°. Majority joints were vertical joints, with the strike and dip of 270° - 295° / 70° - 85° N and 175° - 192° / 65° - 85° W. The uniaxial compressive strength of conglomerate sandstone and quartzitic sandstone estimated from the Schmidt rebound number was about 100 MPa, showed a high value compared to SS rock unit's uniaxial compressive strength. Sand grains are well cemented and sorted. Joint spacing of the rock mass was varied from 20 cm to 300 cm. Joint persistence was in North-South and NWW-SEE. The depth of pot holes was 10 cm- more than 5 m. The groundwater seepage has not been found. The rock mass was rated as a very good rock

mass. The shear strength properties of the rock masses, estimated by RMR, presented the internal friction angle and cohesion as more than 45° and more than 400 kPa. The centerline of dam shows a very good rock condition. The upstream part of the dam is a rapid, known as Soundpan Boak (20,000 pot holes). The pot holes can be fulfilled by the dental grout or replaced by concrete.

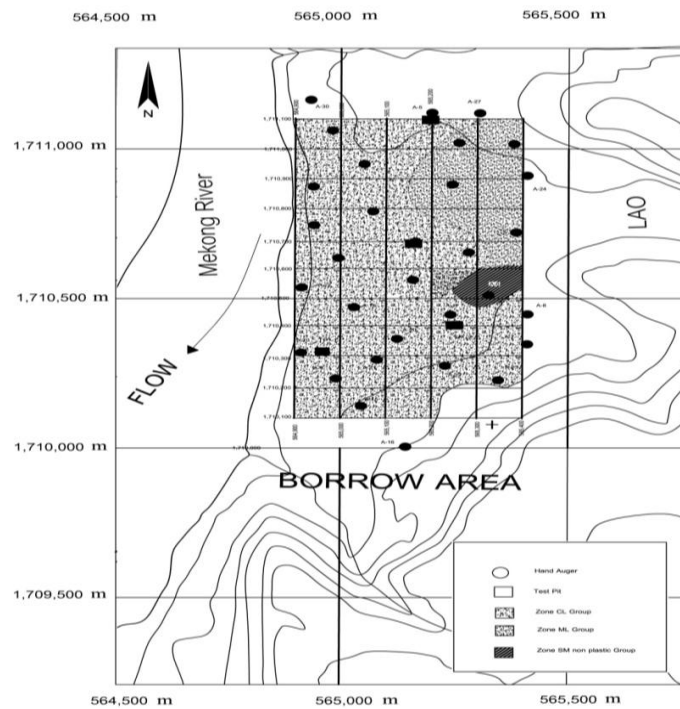
Figure 3. Location of Borrow Area

Borrow area was located in north of the dam site or at the up-stream area as shown in Fig. 3. During investigation, boat trip was used. There was no local road accessed to the borrow area. The borrow area was low intensity of the big trees and was covered by grasses and bamboo. The topsoil was about 0.3 m thick. The average depth of soil layer for construction material is about 3.6 m.
