ATINER's Conference Paper Series

ARC2014-1087

**Graphic Representation and Military
Architecture: The Trace of the
Fuenterrabía Fortifications in the
Current City**

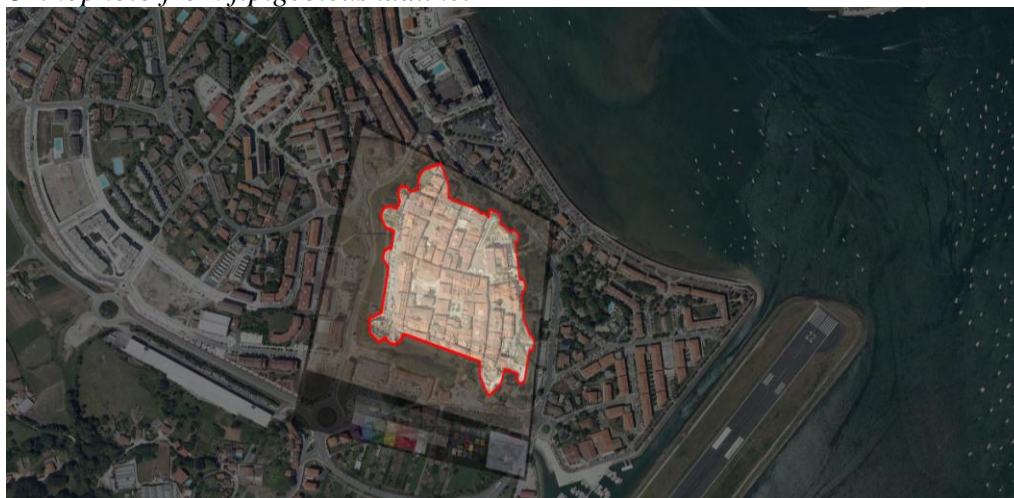
Figure 1. *Own Production: Overlay of AGS. M. P. y D. XIII-55 and Aerial Orthophoto from ftp.geo.euskadi.net*

As was the case with population centres in strategic locations, Fuenterrabía, in the Bidasoa mouth and French border, had medieval city walls dominated from the inside by a defensive tower since its original foundation. But it was after the annexation of Navarre to Castile, in the historical and cultural birth of modern states, when it experienced a boom of defensive buildings and got a new bastioned enclosure. The Catholic Kings built over the old defensive tower a castle, being later enlarged and restored by order of Charles V⁴. In 1476 and 1477 Fuenterrabía suffered two sieges by French troops during the campaigns of defence of the rights of Queen Isabella against Joanna *la Beltraneja*. From the second decade of the sixteenth century, the towers, battlements and walls were lowered to provide embanked masses of soil contained by masonry walls finished with meticulous ashlar. The first bastions were built. But the truth is that the real transformation came later, once the design of the modern bastion had matured. A modern defensive belt wrapping the existing medieval was decided to be built due to the constraints of the terrain, removing some old medieval towers or substituting other by bastions. This can be appreciated in the first graphic document of the fortifications, previous to 1530, preserved in the Archives of Simancas⁵.

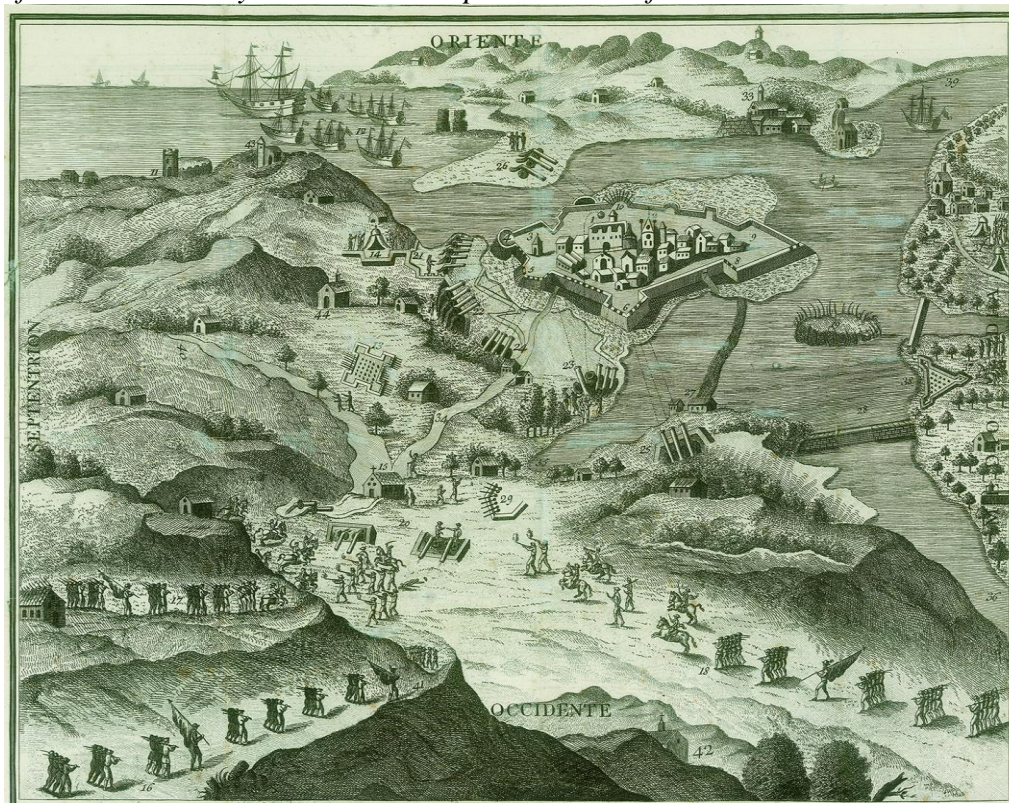
Figure 5. *View of the Stronghold of the City of Hondarribia during the Assault of the French Army in 1638. Municipal Archives of Hondarribia*

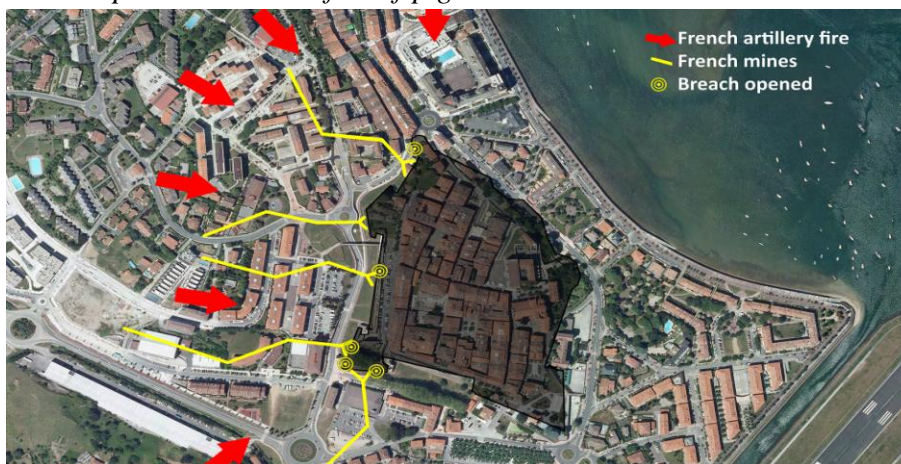
Figure 6. *French Attacks. Own Production: Warfare Diagrams Overlaid with Aerial Orthophoto Extracted from ftp.geo.euskadi.net*
