ATINER's Conference Paper Series

ARC2014-1095

**The Western Sardinian Coast Defensive
Towers (16th-17th Century): An
Interdisciplinary Approach for the
Chronological Definition of Masonries**

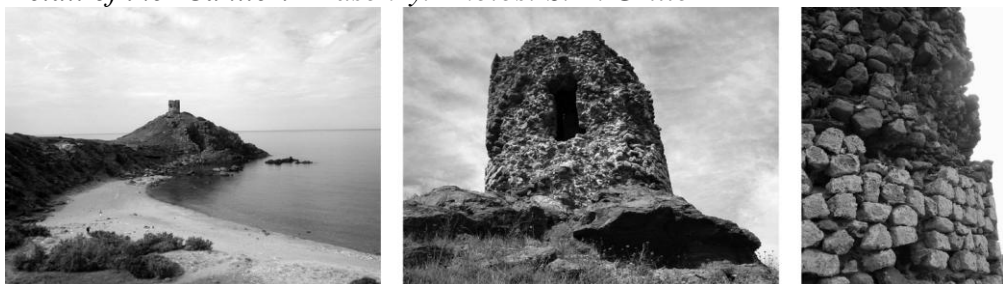
Figure 1. *Columbargia Tower. Panoramic View of the Tower, its Structure and Detail of the ‘Cantieri’ Masonry. Photos: S.M. Grillo*

The masonry is characterized by a rubble stones wall, with evident horizontal planes indicating the passage between two ‘cantieri’ high 55-60 cm. It is largely realized with medium-sized elements. The homogeneity of the masonry texture is interrupted by few rows of ‘*panchina tirreniana*’. They are characterized by a more regular size and shape.

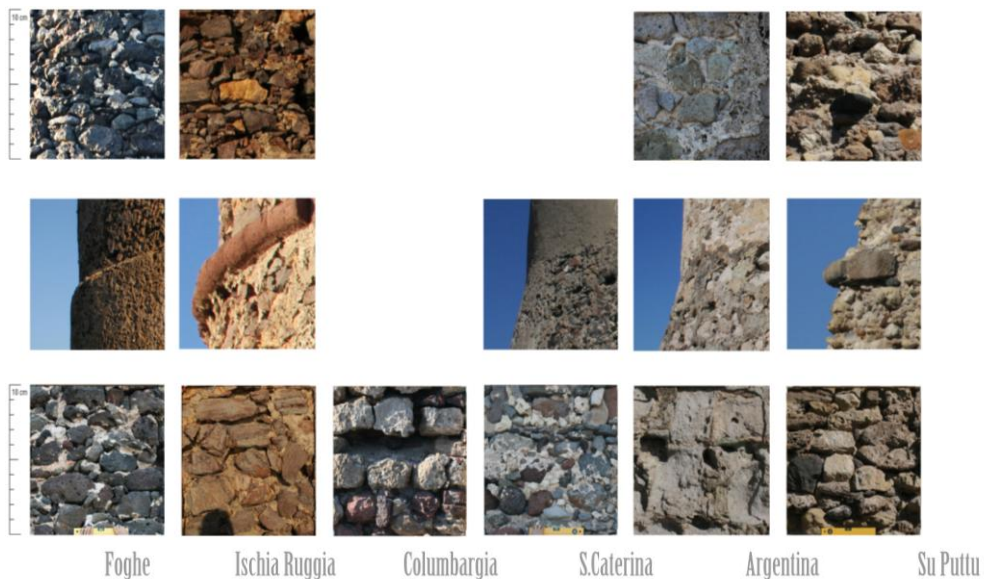
Figure 4. *Details of Masonry Referring to Some of the Towers Investigated. The Comparison Highlights the Different Masonry Textures that Characterize the Basis and the Upper Body of Each Tower and the Constructive Solution Adopted for the Connection between the Two Bodies. Graphic Realization: S. Murru*

The masonry technique used was ‘a cantieri’. This practice, deriving by the roman *opus incertum*, consisted in the preparation of two or three courses of rubbles, rough-hewed just in the external and support faces. The result was an irregular, coarse opus, with horizontal linings generally distanced 50-60 cm, characterized by thick joints between one another, with mortar of poor quality, sometimes signed by not slaked lime nodules. Very often the assembly of the rubble stony elements took place without paying attention to the stagger of vertical joints (Figures 4-5).

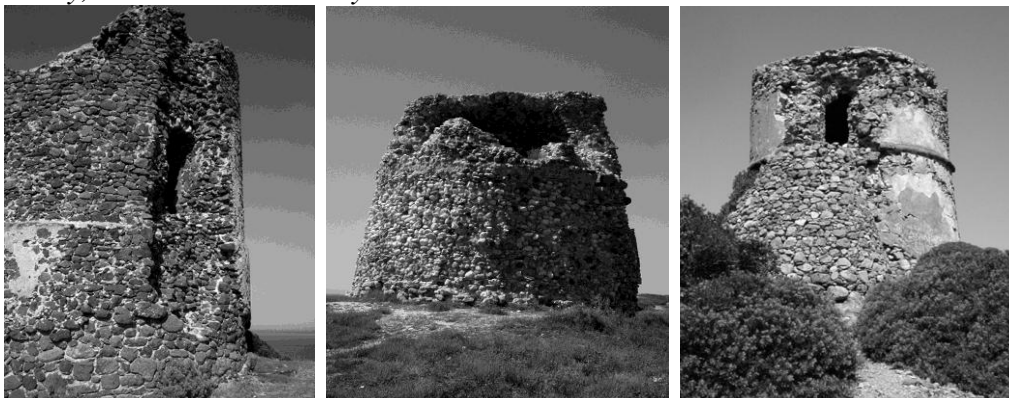
Figure 6. *Foghe, Su Puttu and Iskra Ruia Towers. All These Examples Are in Bad Conditions, because Neglected. All the Images Put in Evidence the Various Questions of Degradations, i.e. Erosion, Alveolization, Anthropical Decay, Structural Instability. Photos: S.M Grillo*

The walls of the towers generally were all made of irregularly and partly regularly cut blocks of different kind of rhyolites and sandstones and only in the construction of the Foghe tower mainly rounded river stones of basalts and phonolites were (Figure 6).
