**ATINER's Conference Paper Series
ART2019-2697**

**The Deterioration of Domestic Wooden Surfaces of
Historical Buildings in Upper Egypt**

**Mahmoud Ali
Lecturer
Conservation of Archaeology Department, Faculty of
Archaeology
Egypt**

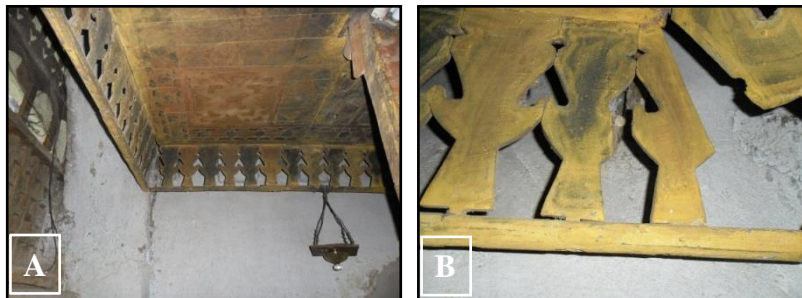
Figure 3. *An Example of the Wooden Vegetal Ornamentation within the Altar in The Bishop Badaba Monastery*

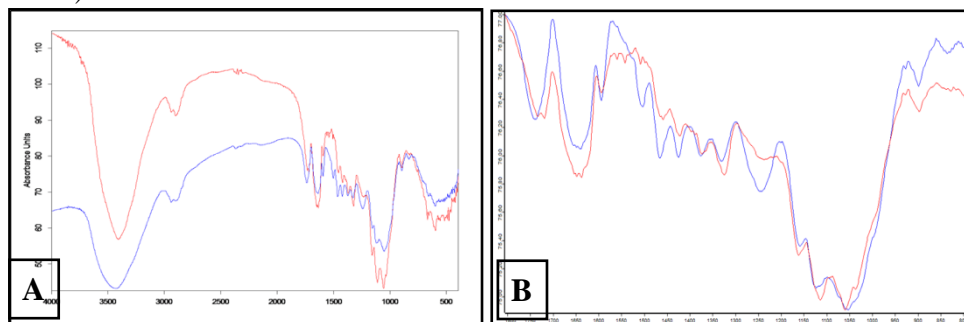
Figure 5. *FTIR Transmission Spectra of the Reference Sample and Sample from Wikalat Al Gedawy lintel, (A) 400-4000 cm^{-1} (B) 800-1800 cm^{-1} (fingerprint areas)*

After examining the samples using FTIR and compared with the standard sample, significant a lot of changes can be observed especially in the fingerprint area of the FTIR in all samples.

This is also evident in the study of samples using FTIR where it was observed that the absorption spectrum in the water area 1640 cm^{-1} was decreased in all the samples compared to the standard samples (Picollo; et al, 2011), (Zidan; et al, 2016). This explains the phenomenon of the spread of micro cracks with different directions, resulting from the severe dryness suffered by these woods as a result of direct exposure to the sunlight.

The reduction and changes in band density and discovering new shapes (New shoulders) at $1730\text{-}1738\text{ cm}^{-1}$ it was a result degradation of the hemicelluloses (Xing; et al, 2015).

The effect of the weathering factors on the domestic archaeological wood cellulose is observed in the study of the FTIR spectrum characteristic of the crystallization of cellulose in the region ($1155\text{-}1165\text{ cm}^{-1}$). It is noted that the absorption is clear in the standard sample with a decrease and weakness in the archaeological samples, which indicates the cracking of cellulose chains As a result of weathering effect (Lionetto; et al, 2012), (Zidan; et al, 2016). The changes in the peaks at 898 cm^{-1} for all the samples are related to CH distortion in amorphous cellulose (Reinprecht; et al, 2018).

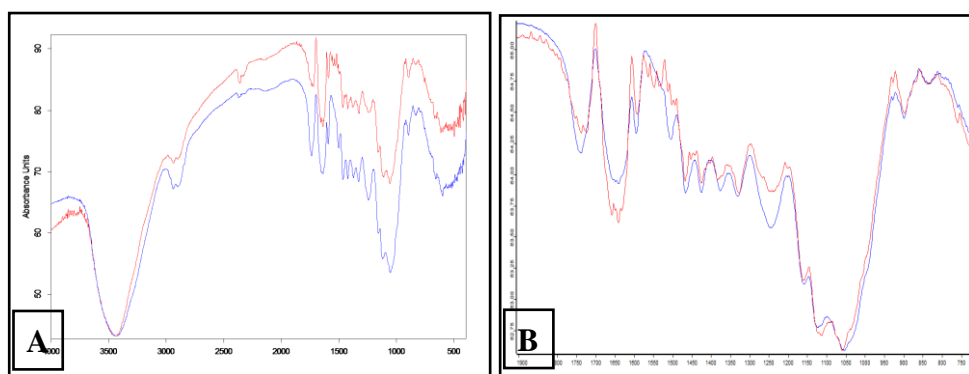
Figure 8. FTIR Transmission Spectra of the *Reference Sample* and Sample from the *Bishop Badaba Vegetal Ornamentation*, (A) 400-4000cm⁻¹ (B) 800- 1800cm⁻¹ (fingerprint areas)

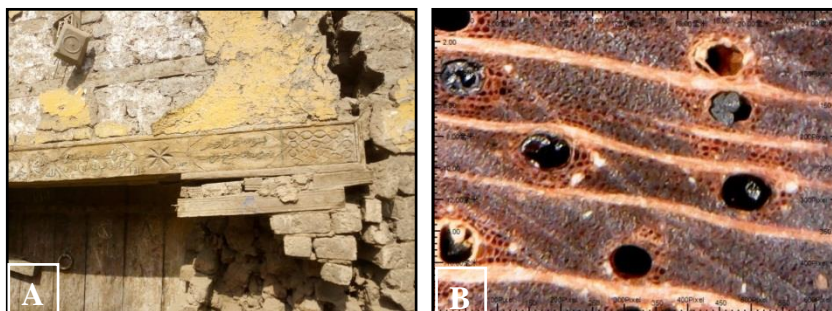
The use of acacia wood was used for many purposes such as wooden butterfly joints in the temple of Dandara, in addition to its use in the external lintel of a historic building in the city of Esna, the house of EL-Sayed Abu Hussein.

Figure 10. (A) Wooden Lintel in the House of EL-Sayed Abu Hussein⁷, (B) Cross-Section of *Acacia sp*

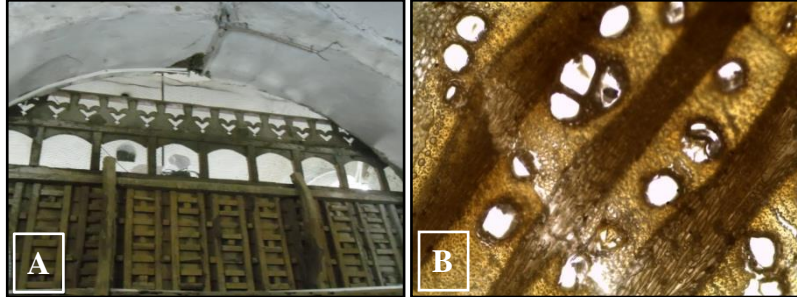
This wood was also used in the interior part of the wooden Iconostasis in the Bishop Badaba monastery, in addition to some interior small panels, especially in

the entrance door of the Altar, which is in the middle of the Iconostasis, in addition to its use in some of the vegetal decorations within the Altar.

Figure 13. (A) *Wooden Iconostasis in the Bishop Badaba Monastery*, (B) *Cross Section of Tamarix sp*

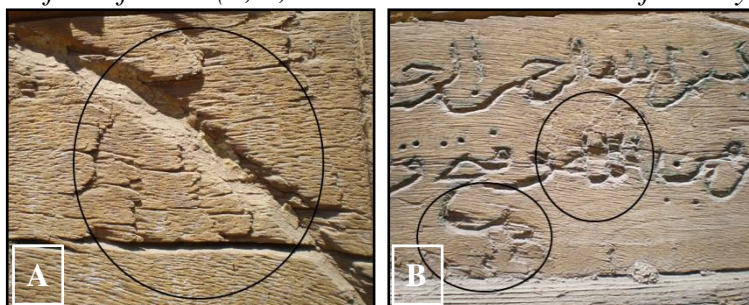
The surface changes of domestic wood are represented in spread of fine cracks, over time due to their continuous exposure to weathering factors (John A; et al, 1993); they are transformed into large cracks that may lead to the division of wood panels (Shrivastava, 1997, Yildiz, et al, 2011).

Figure 16. *The Spread of Various Cracks in the Surface of Domestic Wood in Archaeological Buildings in Upper Egypt, and Loss of some parts from the Surface of Wood (A, B, Wooden lintel in the house of EL-Sayed Abu Hussein)*

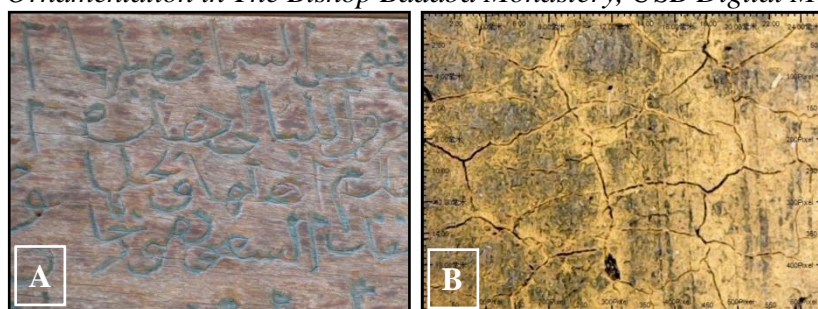
One of the changes at the surface appearance, resulting from the exposure of the ancient wood to the influence of weathering factors directly, is the phenomenon of color change of these woods' outer surface (John; et al, 1993) as a result of the light oxidation process for both lignin and wood extractives (Feist, 1990, Sandberg, 1999, Williams, 2005, Yildiz, et al, 2011, Huang, 2012, Kocaefe; et al, 2012).

Figure 25. Demonstrate the Effect of Weathering Factors on the Layers of Color, (A) Wooden Lintel in House of Mohammed Mujahid, (B) Wooden Vegetal Ornamentation in The Bishop Badaba Monastery, USB Digital Microscope
