CIV2014-0948

**Experimental Behavior of Rectangular
Shear Walls Subjected to Low Axial
Loads**

**Bahadir Yuksel
Associate Professor
Selcuk University
Turkey**

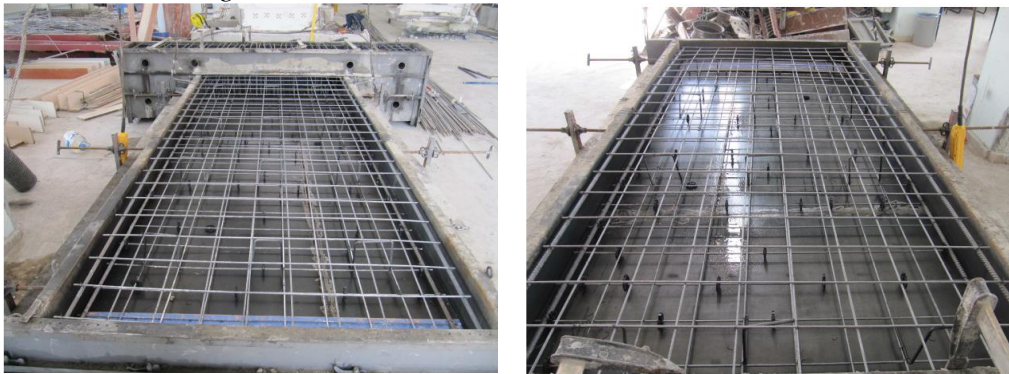
Figure 4. General View of the Shear Wall Test Specimen (SW) in the Construction Stage

foundation having 0.7 m width, 3.0m length, and 0.5 m thickness. The rigid foundation was clamped to the laboratory strong floor by high-strength steel bolts. Figure 2 shows the plan view of the reinforcement layouts of the shear-wall test specimen. Plan view of the test specimen and the foundation is presented in Figure 3. The photographs in Figure 4 show the general view of the shear wall test specimen in the construction stage. The photographs in Figure 5 show the pouring the concrete of the shear wall test specimen.

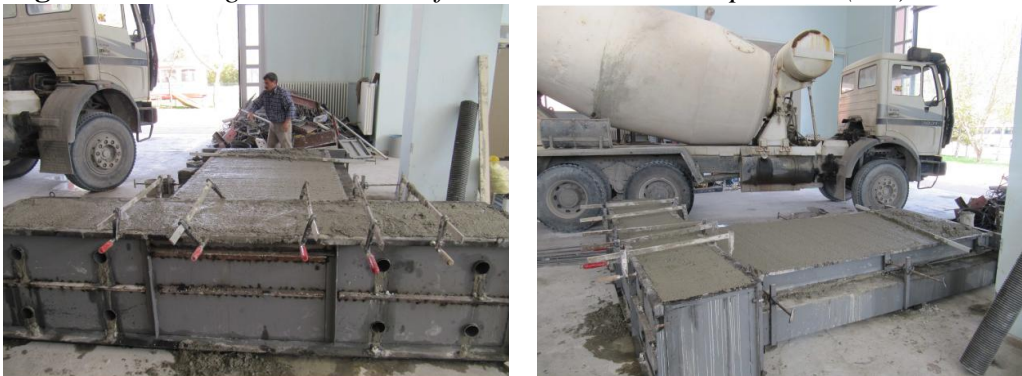
Figure 5. Pouring the Concrete of the Shear Wall Test Specimen (SW)

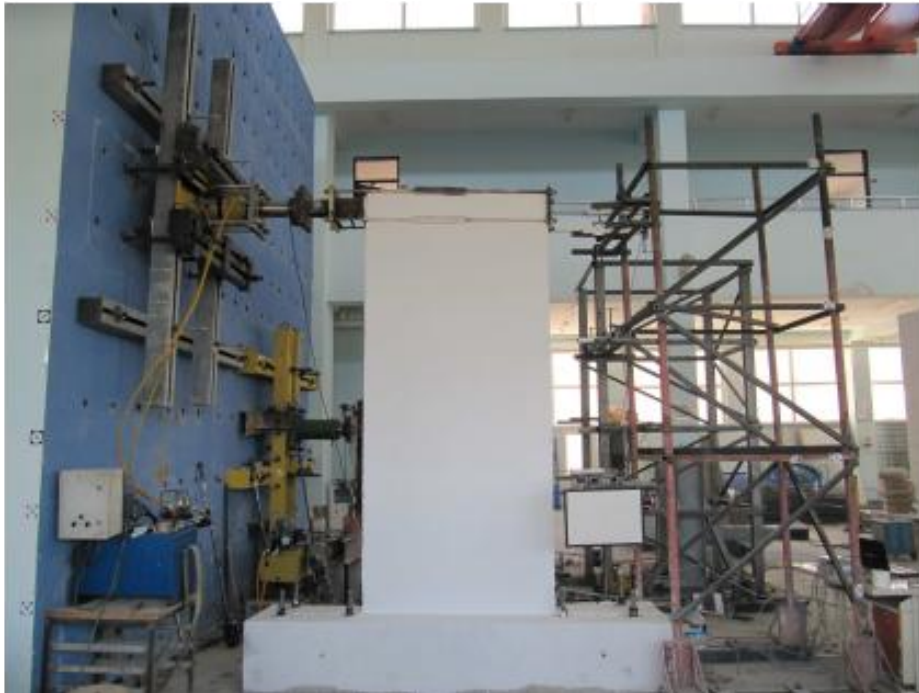
Figure 6. *Test Setup, Loading System and Instrumentation of SW*

Figure 6 shows the test setup used in the experimental program. The testing system consisted of strong floor, reaction wall, loading equipment, instrumentation and data acquisition system. The lateral loading system consisted of a load cell, hydraulic jack and hinge. Instruments were used to measure loads and displacements for the specimen. Load cell measured the lateral loads applied to the specimen. Strain gage-based linear variable differential transformers (LVDTs) and dial gages (DGs) were used to measure the displacements. Five linear variable differential transformers (LVDTs) were mounted to measure the lateral displacements over the wall height. An LVDT was mounted horizontally on the foundation to monitor any horizontal slip of the foundation along the reaction floor.

The testing was performed to determine the inelastic seismic behavior of the SW. The specimen included the test wall portion and a strong foundation block used to reproduce realistic base condition. The foundation block was purposely designed significantly thicker than the test wall to limit cracking in the foundation. The wall and foundation portions were cast continuously without cold joints. The specimen was mounted vertically on the strong floor of the laboratory and the load was applied by a 500 kN actuator with pinned end conditions.

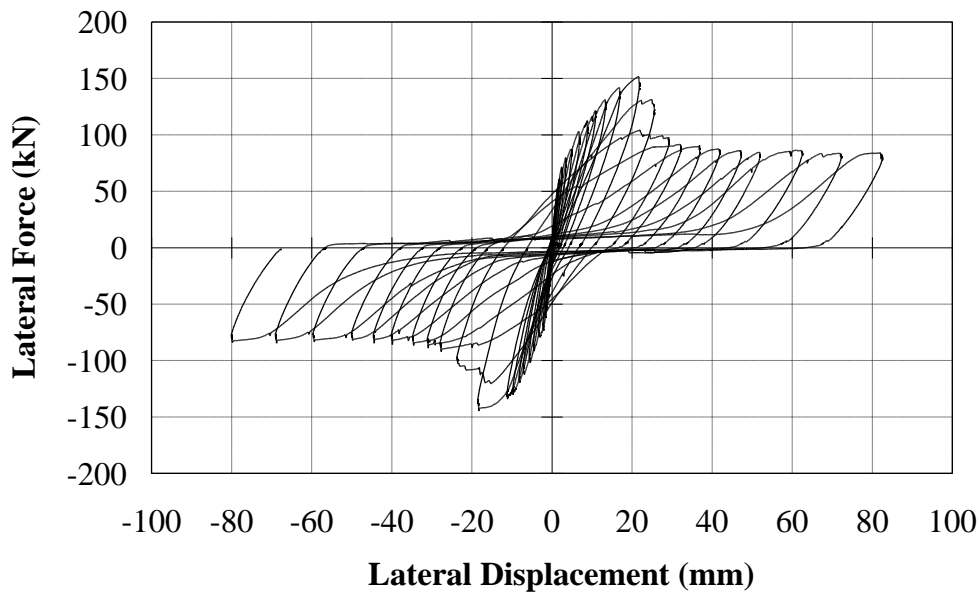
Figure 10. *Lateral Force versus Lateral Top Displacement Relationships*

toward the centre of the wall. This was followed by the crushing of the concrete in the boundary regions. Figure 8 shows the cracking patterns of SW at -35mm and -40 mm lateral displacements. The final stage was buckling of the boundary reinforcement and tearing of all the mesh reinforcements at the foundation level. The test was stopped due to tearing of the all the vertical mesh reinforcements and buckling of the boundary reinforcement. Collapse of SW characterized by the existence of a wide crack at the base level (Figure 9), thus showing a higher tendency to localize plastic deformations in cold drawn mesh, due to lack of strain hardening. All the longitudinal bars of the cold drawn mesh reinforcements just above the foundation level were broken. The concrete in the boundary regions were crushed. Figure 9 shows the general view of SW at failure stage. Figure 10 shows the horizontal lateral force - lateral top displacement curves for the SW subjected to a horizontal cyclic force. Maximum lateral load capacity of the SW was 150 kN.
