ATINER's Conference Paper Series

CIV2014-0967

**Shear Behavior of RC Slender Beams
with Corrosion-Damaged Stirrups**

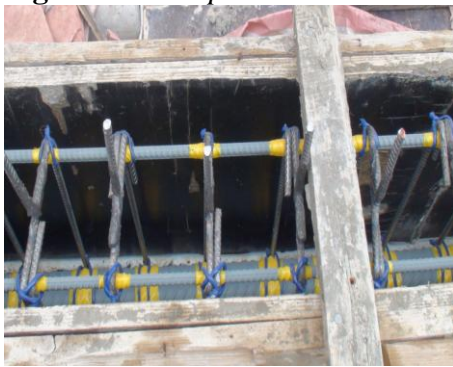
Figure 2. Stirrup Electrical Connection

For the corroded stirrups, an electrical connection had to be made between the stirrups and power supply. A steel bar was welded to the stirrup and extended outside the specimen to complete the electrical connection, as shown in Figure 2. The ties used to attach the corrosion stirrups were wrapped in electrical tape to prevent an electrical connection with the longitudinal reinforcement. Also, the longitudinal reinforcement was covered with electrical tape at the stirrups location. The longitudinal steel bars were epoxy-coated to preclude corrosion of these elements. A 10 mm diameter stainless steel tube was bent into a U shape and embedded within the concrete around the corroded stirrup to serve as a cathode.

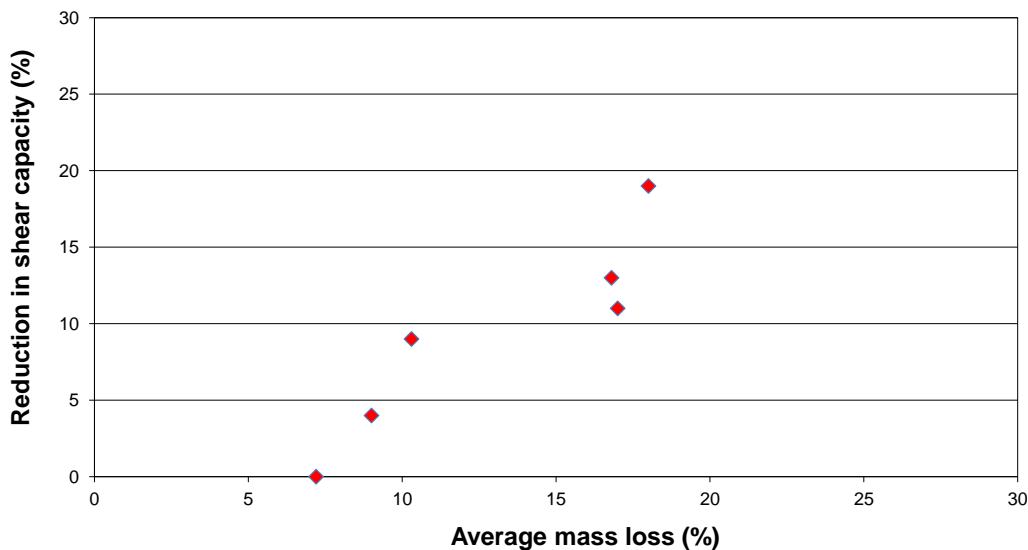
Figure 6. *Variation of Reduction in Shear Capacity with Average Mass Loss*

The variation of the reduction in normalized shear capacity was plotted against the degree of corrosion in terms of average mass loss as presented in Figure 6. The figure indicates that more corrosion damage in the stirrups causes more reduction in shear capacity of the beams. The effect of the stirrup spacing on the reduction in shear capacity is presented in Figure 7. The general trend in the figure indicates that the reduction in shear strength became larger for beams with closely spaced stirrups. This result may be expected because more corrosion cracks were developed in such beams in comparison with beams of wider stirrup spacing.
