**ATINER's Conference Paper Series
CIV2015-1845**

**Influence of Strengthening the Infill Walls
with Perforated Steel Plates on the Behavior of
RC Frames**

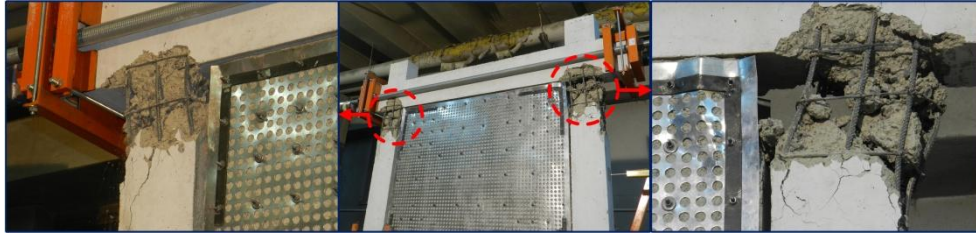
Figure 2. *Shear Failure of the Columns in Specimen S1ZN200*

In the test of Specimen S1ZN200, the effect of using perforated steel plates for strengthening the infill wall could not be fully understood since this specimen failed prematurely due to the shear failure of the columns (Figure 2). The infill wall did not undergo significant damage till the end of the test with the exception of limited crushing in the corners (Figure 2). To avoid the premature failure of the weak columns and to allow the strengthened wall to contribute to the frame behavior, the columns and the beam-column joints in the remaining specimens, were strengthened, in addition to the infill wall. Accordingly, the following additional strengthening measures were undertaken in the remaining strengthened specimens:

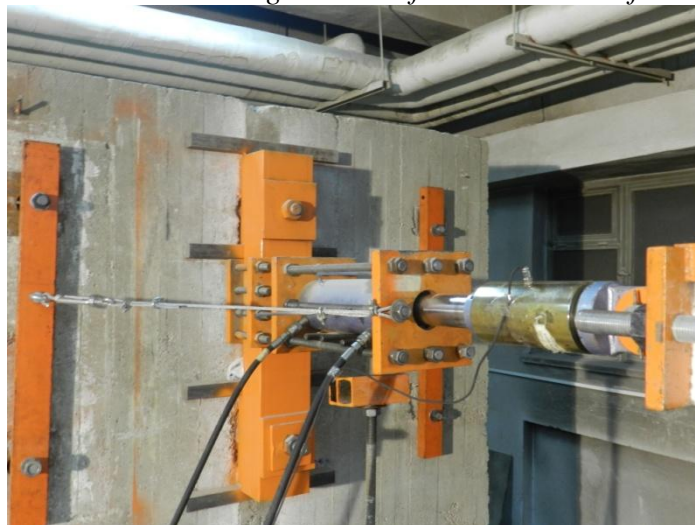
Figure 3. *Steel Cables Preventing the Out-of-Plane Motion of the Jack*

Each test specimen was composed of a rigid foundation (Figure 1), two columns, a beam and an infill wall. The lateral load was applied by a double-action hydraulic jack, connected to a strong wall. In the tests of S1.5ZY150, S2ZN150, S2ZN200, S2ZY150 and S2ZY200, the out-of-plane motion of the hydraulic jack was prevented by steel cables connected to the strong wall (Figure 3). The lateral displacements of the frame at the center of the beam (floor level) and at mid-height of the column were measured with the help of LVDT's. An additional potentiometer was used for measuring any possible lateral displacement at the lower end of the column, indicating the separation between the column and the rigid foundation (Figure 4). Two LVDT's aligned along the wall diagonally measured the diagonal deformations in the wall. Finally, the rotations at the lower end of each column were measured by two LVDT's connected by a rigid link, oriented horizontally at the initiation of the test (Figure 5).

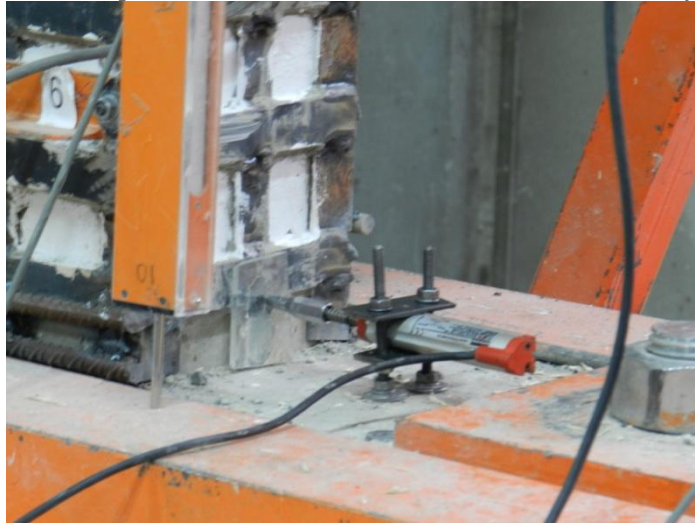
Figure 4. *Lateral Displacement Measurement at the Lower End of the Column*

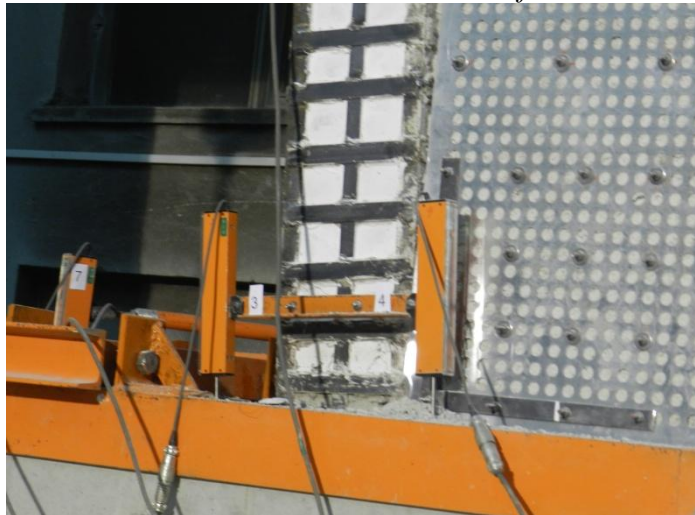
Figure 5. *Rotation Measurement at the Lower End of the Column*

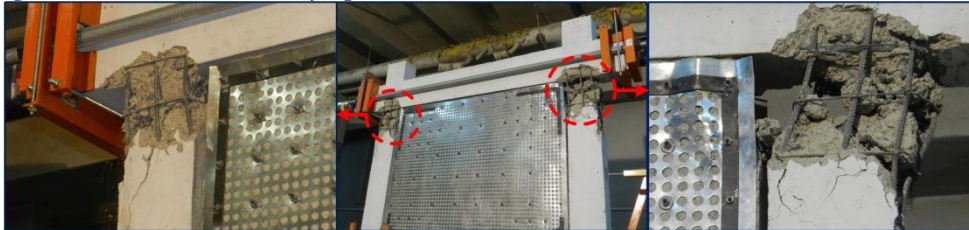
Figure 8. Failure Mode of Specimen S1ZN200

Specimen S1ZN200 behaved similar to the reference R2 specimen and the influence of wall strengthening on the overall frame behavior could not be observed due to the premature shear failure of the weak columns (Figure 8). The infill wall did not experience significant damage except the limited crushing in the corners. The shear cracks in the upper portions of the columns controlled the frame behavior throughout the test and the load capacity of the frame slightly exceeded the load capacity of the reference frame R2 (Table 2). The ultimate load values of S1ZN200 was about 28 % and 38 % higher than the ultimate load values of R2 in the forward and backward directions.

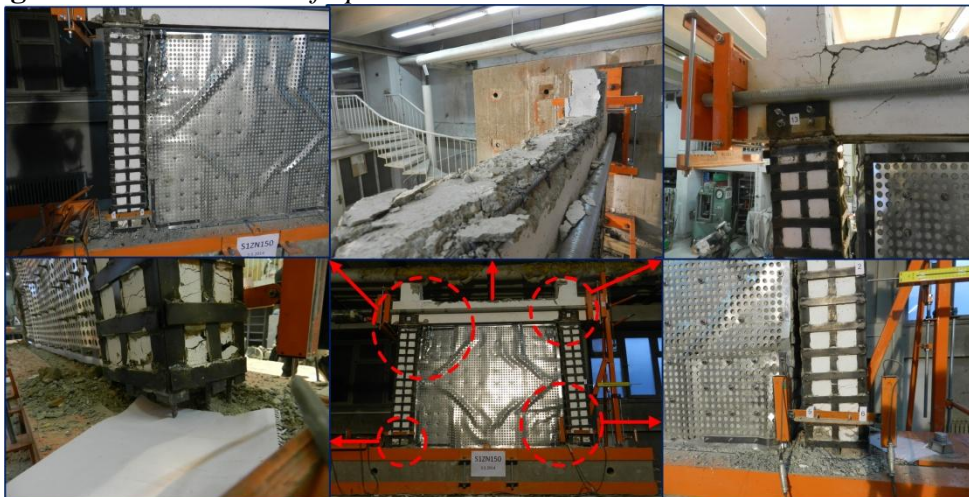
Figure 9. Failure Mode of Specimen S1ZN150

Due to the shear failure of the weak columns of S1ZN200, the additional strengthening measures summarized in the previous section were realized in the remaining tests. As a result of this strengthening, all of the remaining specimens exhibited a quite ductile behavior (Figures 9-19).

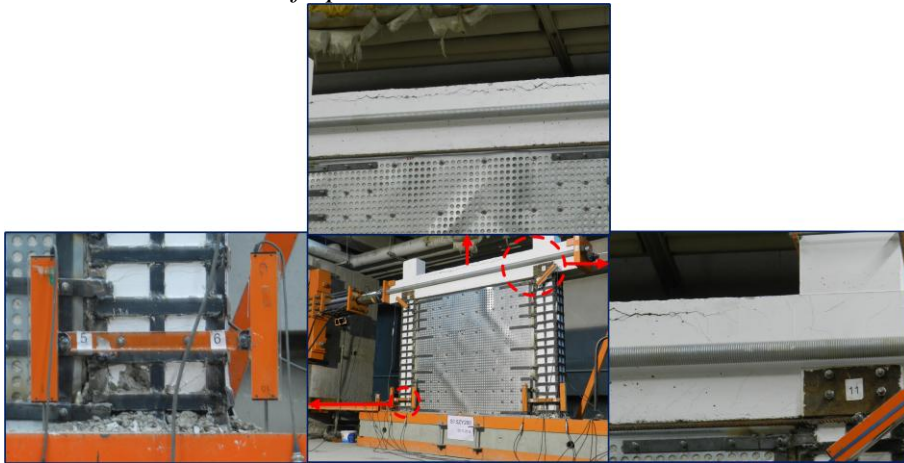
Figure 10. *Failure Mode of Specimen S1ZY200*

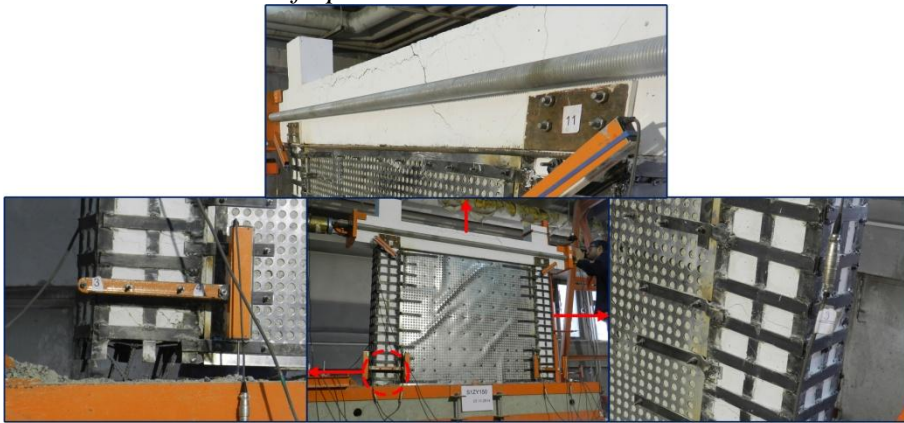
Figure 11. *Failure Mode of Specimen S1ZY150*

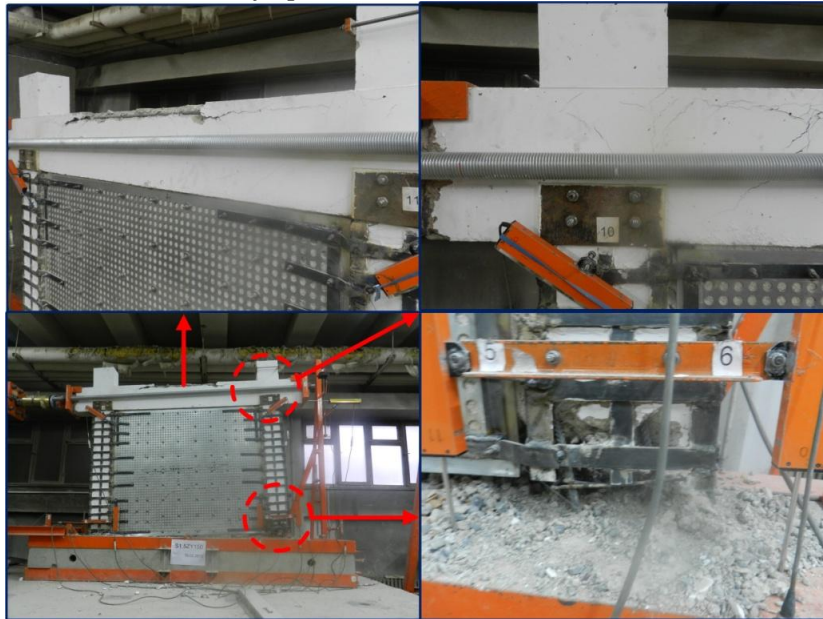
Figure 15. *Failure Mode of Specimen S1.5ZY150*

- The separation between the lower ends of the columns and the rigid foundation caused rupture of the longitudinal bars of the columns (Figure 15), upon which the tests were generally terminated.
- Diagonal shear cracks formed in the columns due to the low compressive strength of concrete. However, the steel jacket around the columns prevented these shear cracks to control the behavior of the frame and the premature shear failure of the columns.
- The diagonal compression forces in the wall resulted in buckling of the perforated steel plate segments between successive anchors (Figure 14). Nevertheless, the strengthening plates continued contributing to the

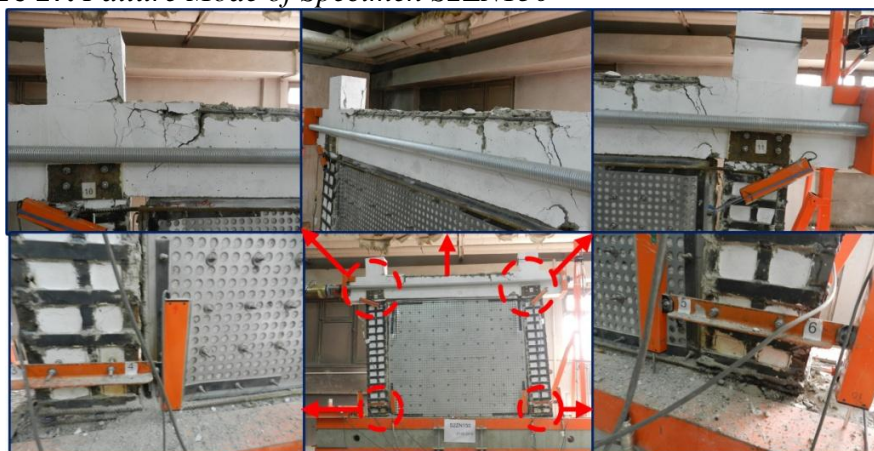
Figure 17. *Failure Mode of Specimen S2ZN150*

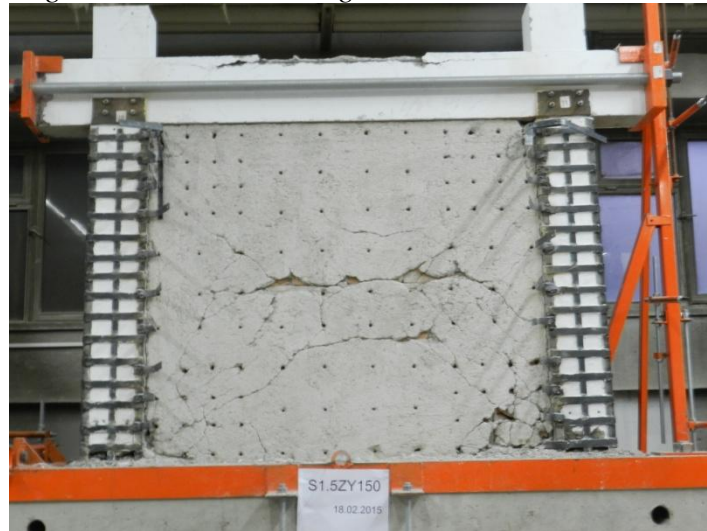
Figure 20. *Diagonal Tension Cracking in the Walls*

- Four plastic hinges at the upper and lower ends of the columns and two plastic hinges at the ends of the beam formed.
- At the level of the top longitudinal reinforcing bar of the beam, significant debonding cracks formed as a result of the low compressive strength of concrete. These cracks are not considered worrisome since the slab projecting from the beam in real frames prevents debonding cracks to form at the top of the beam.
- Diagonal tension cracks developed along the wall (Figure 20). However, the perforated steel plates prevented disintegration of the wall and provided the frame with ductile behavior. Consequently, the diagonal tension cracking along the diagonals and crushing in the corners remained rather limited.
- In specimens S1ZN150, S1ZN200, S1.5ZN150, S1.5ZN200, S2ZN150 and S2ZN200, significant separation at the wall-column interfaces took place (Figure 21).

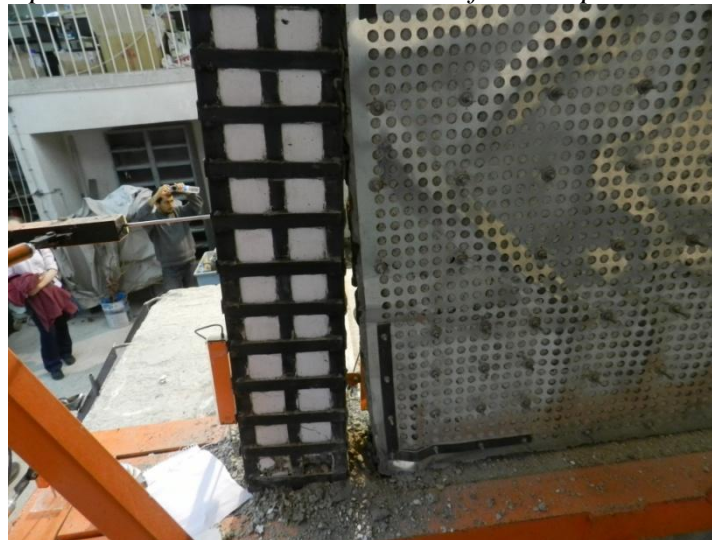
Figure 21. *Separation at the Wall-Column Interface in Specimen S1ZN150*
