**ATINER's Conference Paper Series
CUL2018-2599**

**Structural and Architectural Damage Aspects
of Historic Renaissance Buildings in Egypt and
the Proposed Rehabilitation Methods**

**Mohamed Abdelmegeed
Lecturer
Fayoum University
Egypt**

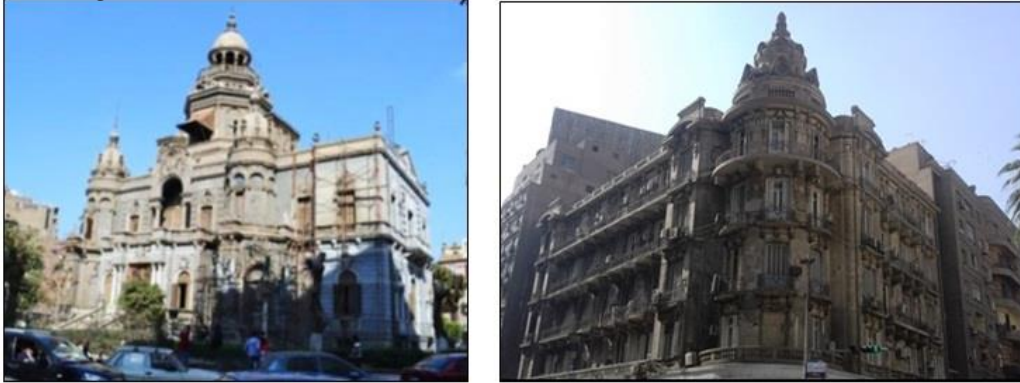
Figure 2. *Examples of Renaissance Structures in Cairo (ElSakakini Palace and Building 35 in Bostan St.)*

In 19th century the demographic image of Cairo state began heavily transformed, in particular its residential urban fabric. Renaissance structures considerably have significant distinctions in construction methods, building materials, architectural components and decorative elements. Renaissance architecture in Cairo is considered to represent the artifacts, structural and architectural trends predominating in Egypt and Europe this period (Baroque, Rococo and gothic style) as shown in Figure 2.

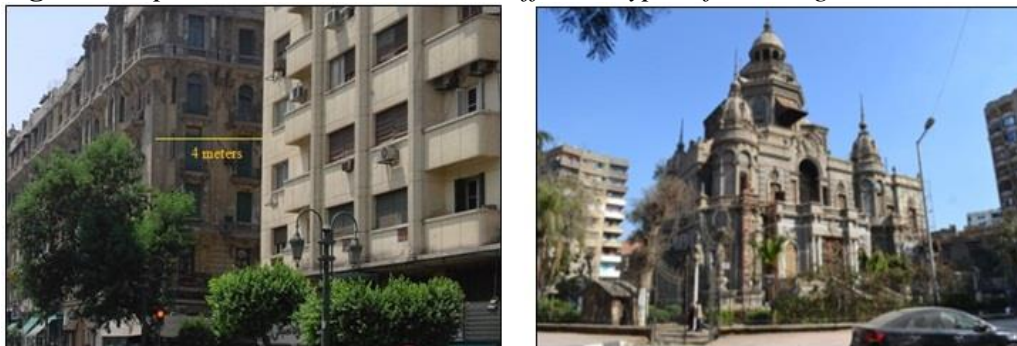
Figure 6. *Separation Distance between Different Types of Buildings*

- The size of the buildings varies from one to the other depending on its use (church, palace or residential house). Thus, plan dimensions vary from some meters to some tenths of meters.
- Buildings have slightly rectangular or square in-plan geometry, with two, three, four or even 6 floors at most.
- The separation distance between buildings varies from 3: 6 meters and more as a rule when separated from adjacent buildings. The separation distance mostly depends on the buildings typology. In spite of this we find that the separation distance between buildings does not exceed 4 meters in some districts; we find that the distance between palaces and adjacent buildings is not less than six meters at least (see Figure 6).

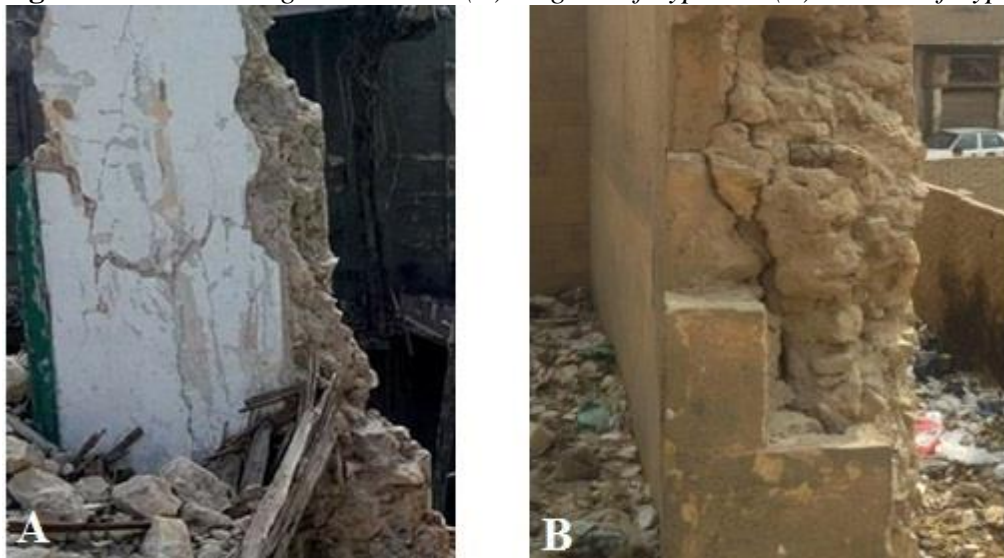
Figure 7. Load Bearing Walls where (A) Single-leaf Type and (B) Three-leaf Type

- Renaissance structures in Cairo built by using local building materials in the shape of blocks (natural stones) or manufactured shape (fired bricks) and a series of mortar joints arranged irregularly (as in stone masonry) or regularly (as in brickwork) (Lopez et al., 1998; Abdelmegeed, 2005). The most building materials used in 19th century buildings are rubble (cobble) and ashlar stones in addition to fired bricks in certain partitions of the building. The structural load-bearing walls are constructed in the form of the single-leaf or of the so-called three-leaf type (with two discrete external leafs and an infill material), with varying thicknesses (less or more than 600 mm) as shown in Figure 7.

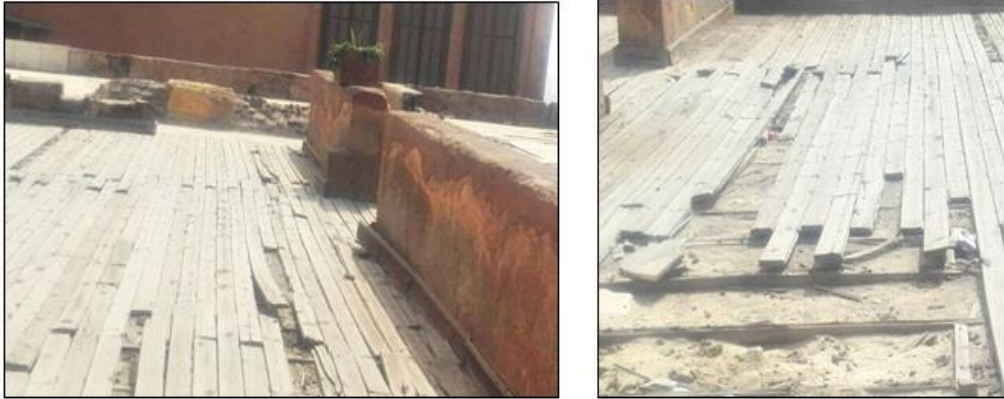
Figure 8. *El-Gohara Palace Roof (Using Sand Overlay under Wooden Planks)*

- Timber floor construction in the form of wooden beams covered with wooden planks, ballast fill, and tile flooring, as shown in Figure 8. Sand or straw overlay is provided in between planks and boards of the roof for thermal comfort. In most cases, timber joists are placed on top of walls without any positive connection (see Figure 8).

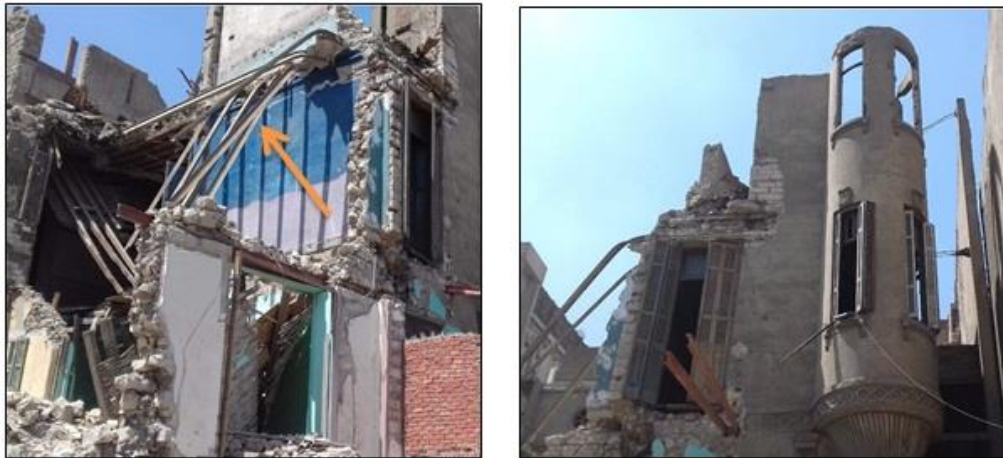
Figure 9. *The Use of Iron Bars in Renaissance Structures (Elmonera District House 1940:1945)*

- Roof/floor timber pegged together by using nails and screw fixings. On one hand 99% of roofs in renaissance buildings in Cairo were constructed in the form of flat roof but approximately 5% of them were covered with the so-called wooden pergola. On the other hand, during in-situ survey to demolished building which dates back to the first quarter of 20th century (Figure 9) it founded that they used iron bars instead of wooden beams. The iron bars were covered with wooden planks.

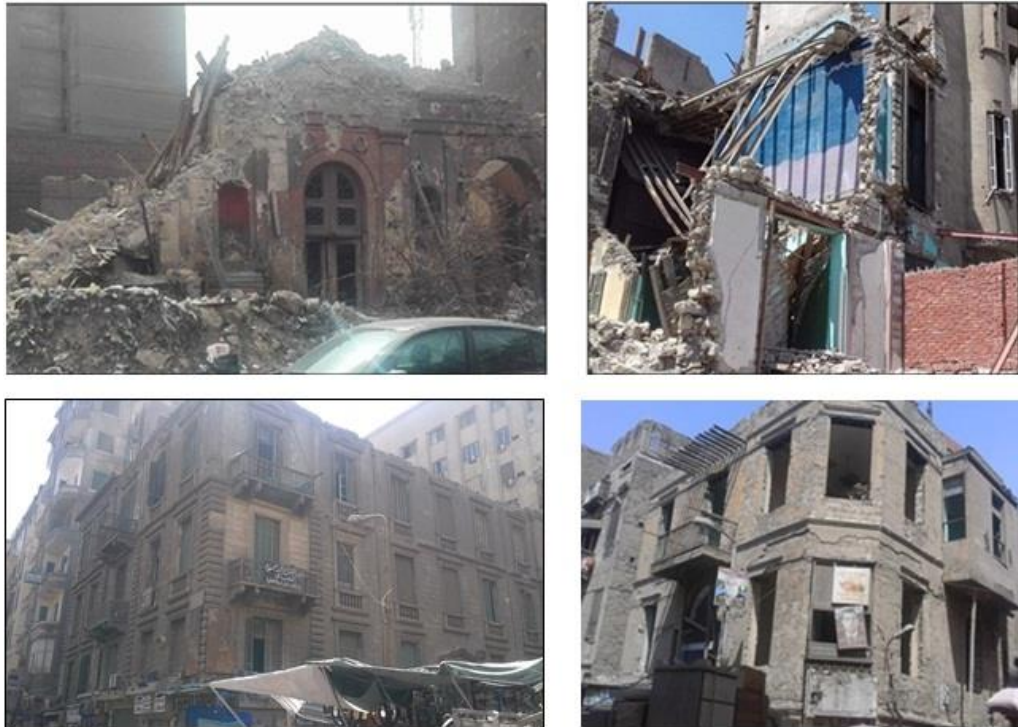
Figure 10. *Structural and Architectural Damage Aspects in Renaissance Buildings in Cairo*

Also, some of historical buildings underwent to some modifications processes, in particular the decrease of the building's height, the elimination of a monumental portal or gate, and replaced the original wooden roof by terraces with concrete slabs and concrete beams. However, these structural modifications lead to significant deterioration phenomena (Figure 10).

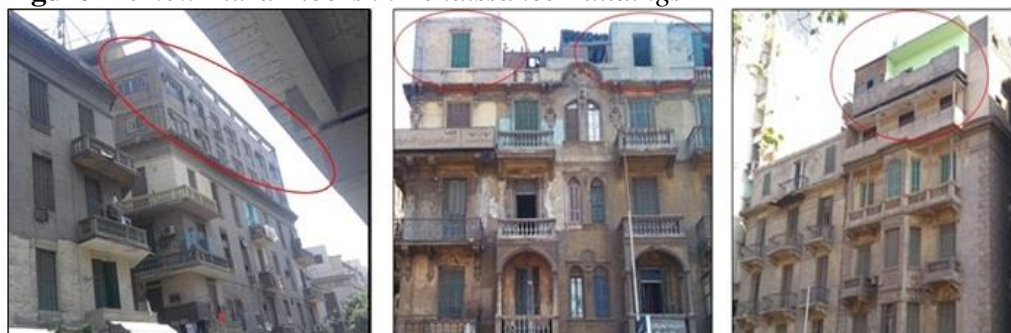
Figure 12. *New Extra Floors in Renaissance Buildings*

Recently, palaces and larger renaissance houses were abandoned into smaller and higher concrete structures. A lot of heritage buildings were re-placed with rental flats, other buildings were used indiscriminately for deferent, mostly unsuitable functions. Otherwise, renaissance buildings in Egypt usually undergo to modification processes. Modification actions take many shapes such as the decrease in height of an entire story, stripped off some of original portals and increment extra floors to the building (Figure 12) and as a result of such modifications the buildings susceptible to serious architectural and structural damage phenomena such as, cracking, settlement, failure in localized regions, building collapse and adversely affect historic character (Abdelmegeed, 2015; Calio et al., 2014).

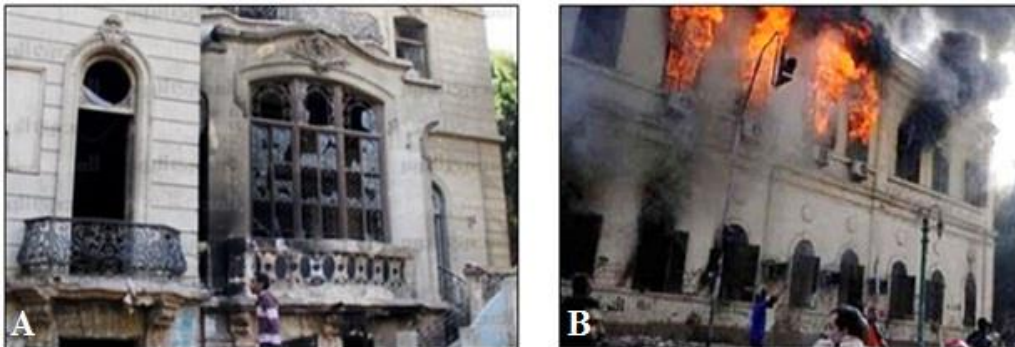
Figure 14. Damage Phenomena during the Following Events of 25th January Revolution where (A) French School Lycée la Liberté de Bab El- Louqe (B) Fire in the Egyptian Science Institute

1. Intentional targeting by hostile groups intending to devastate the racial, national or religious symbols of countries or to impose specific intruder ideologies. Otherwise, the effect of the political fights and instability in the country during 2011 and 2012 was clear on the deteriorations and destructions of some historic renaissance buildings in downtown Cairo, as shown in Figure 14.

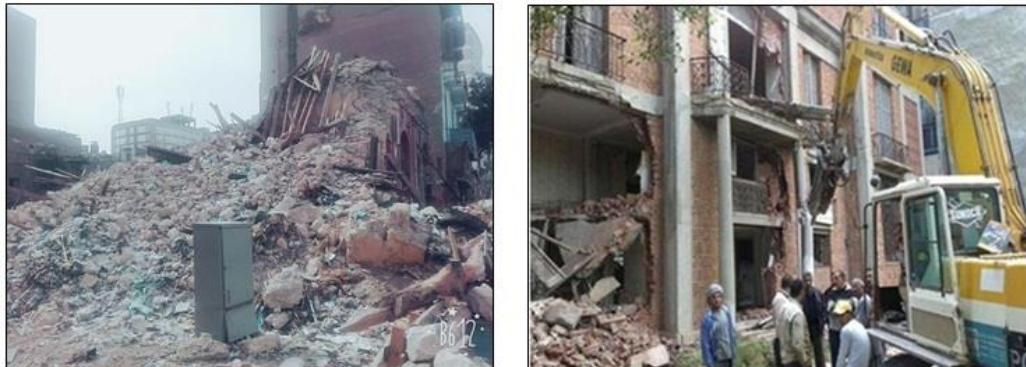
Figure 15. *Destructing Processes to Renaissance Building during the Following Events of 25th January Revolution*

2. The vast majority of renaissance structures follow the individual private ownerships and the owner made their efforts (Exploited of security absence after 25 January revolution) to destruct these buildings (see Figure 15) and rebuilt them in the form of high steel buildings searching of rich
3. Unintentional destruction due to both of the neglect of the value of historic buildings and the absence of governmental role. As a result of neglect the people who lived adjacent to the uninhabited buildings use them as garbage dump.

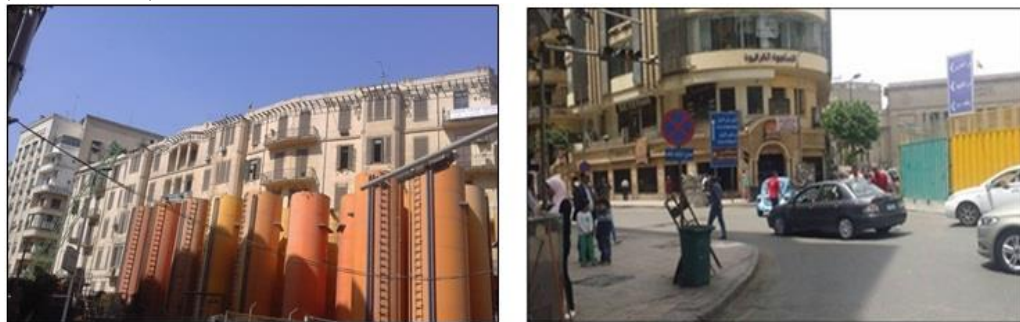
Figure 17. *Metro Tunnel Digging Operations Adjacent to Renaissance Buildings (Downtown)*

Nowadays renaissance structures in khedival Cairo are suffering many deterioration phenomena due to the effect of Cairo Metro Line 3 project. As shown in Figure 17 the project crosses under 23 July Street which has many of renaissance buildings. Vibrations generated by the project running on underground tracks transfer through the ground into surrounding structures. These induced vibrations usually cause no threat to the safety of the structures, but their undesirable impacts can significantly lower the quality of life and the working conditions of these structures. Also there may be concern about the possibility of adverse long-term effects of vibrations on old buildings and historical monuments along metro corridors, especially those in a weak condition (Ziad Nakat, 2014; Twinning Project Fiche, 2015). Many historical buildings located in El-Gaish Street, including dwellings and shops were damaged due to suddenly ground settlement during digging the metro tunnels.

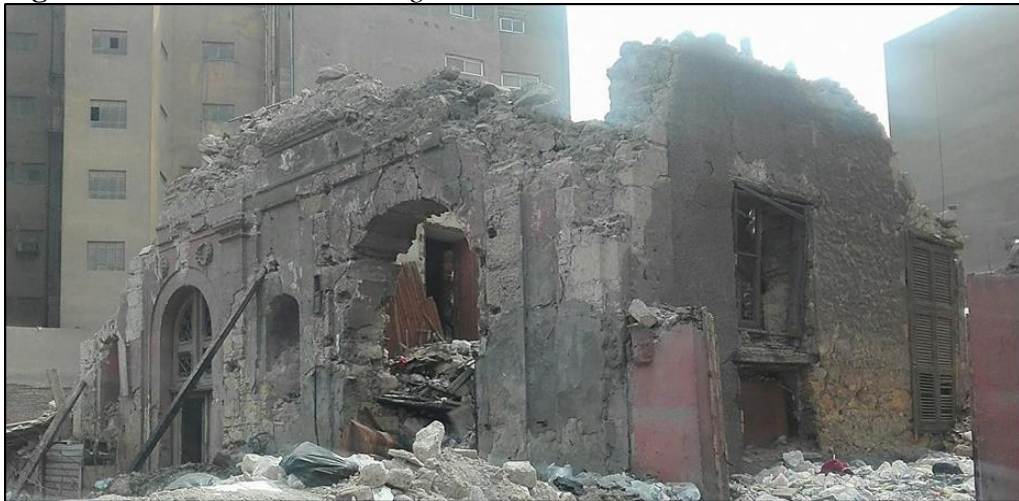
Figure 19. *SABTIYYAH Building*

In the middle of *SABTIYYAH*, to the north west of Ramses square , where the building that forms the subject of the case study is located and will be referred to as “*SABTIYYAH* “ building, thereafter (Figure 19). *SABTIYYAH* building, which was built in the late 19th - early 20th century, is one of renaissance buildings which represent the architectural and structural trends widespread in Cairo this period. By time, this house has suffered significant structural and architectural damage phenomena due to various causes, such as construction defects, seismic excitation, neglect, environmental surrounding factors etc.

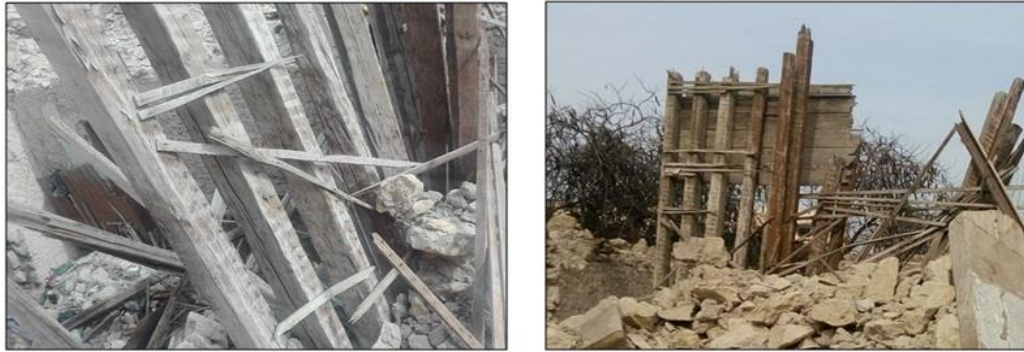
Figure 20. *Typical Semi-chiseled and Chiseled Stones*

Limestone, semi-chiseled and chiseled stones, are the main building materials used for *SABTIYYAH* building the construction of structural and architectural elements (see Figure 20). While Mortar (gypsum mortar), containing a major quantity of sand and a smaller quantity of gypsum.

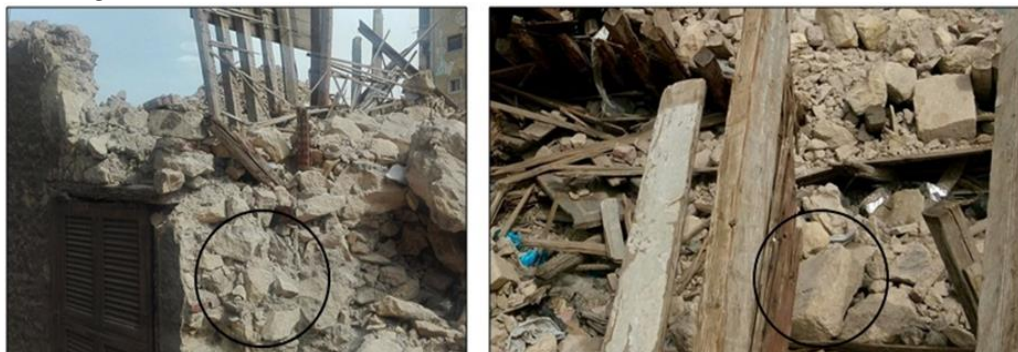
Figure 21. *Timber Beams and Wooden Planks in the Roof of SABTHIYYAH Building*

The structural walls in the building have a width of 0.4 m. They were built with semi-chiseled limestone, bound together with large amount mortar "ashlars masonry". The roof of the building (completely destroyed) was made of, 15 m high x, 11 m wide timber beams arranged in parallel at unequal distances of 50 to 70 cm. Timber beams covered with 35 cm wide x 4 cm thick planks as shown in Figure 21. The beams are simply supported within recesses formed in opposite walls.

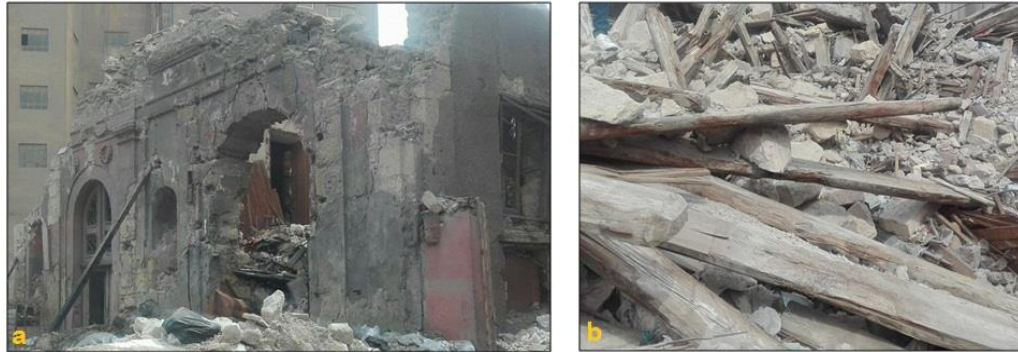
Figure 22. *Structural Damage Phenomena where (a) Failure in Localized Regions and (b) Roof Collapse*

On the other hand the building suffers a localization collapse in its internal and external walls in addition to a whole roof collapse (see Figure 22a and 22b). Wall collapse is due to structural defects (inadequate design) and the use of unsuitable building materials.

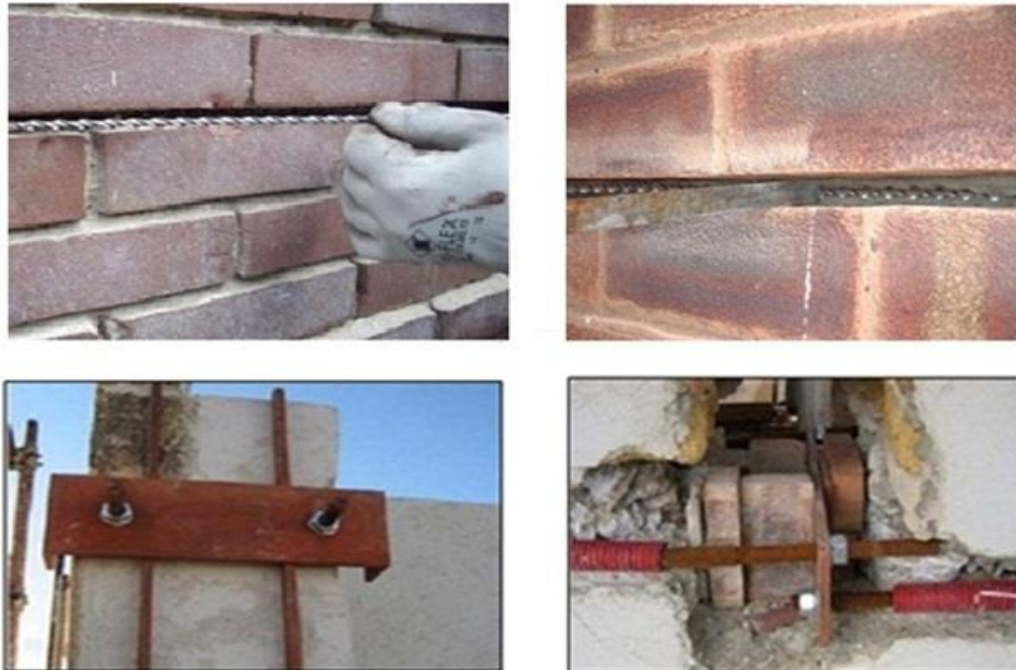
Figure 25. *Stitching Techniques Used in Strengthening Masonry Buildings*

Steel bars to be long enough to extend a minimum of 50cm either side of the crack or 50cm beyond the outer cracks if two or more adjacent cracks are being stitched using one rod. If there is render, this thickness must be added to the depth of slot. Crack stitching must be installed in the masonry and never in the render.

A possible safeguard against this would be to incorporate temporary injection nozzles into the mortar joints to allow grouting of the space behind the stone after the mortar has set (Sayed Ahmed and Shrive, 1998; Beckman and Bowles, 2004). Otherwise the use of steel bars technique (as shown in Figure 25) causes damage due to the corrosion process to these bars leading to cracks in walls. So if necessary we must use the stainless steel bares or use steel bars fixed inside the PVC tubes to easy remove or maintain the corrosion steel and avoid the direct contact between the steel bars and the masonry.

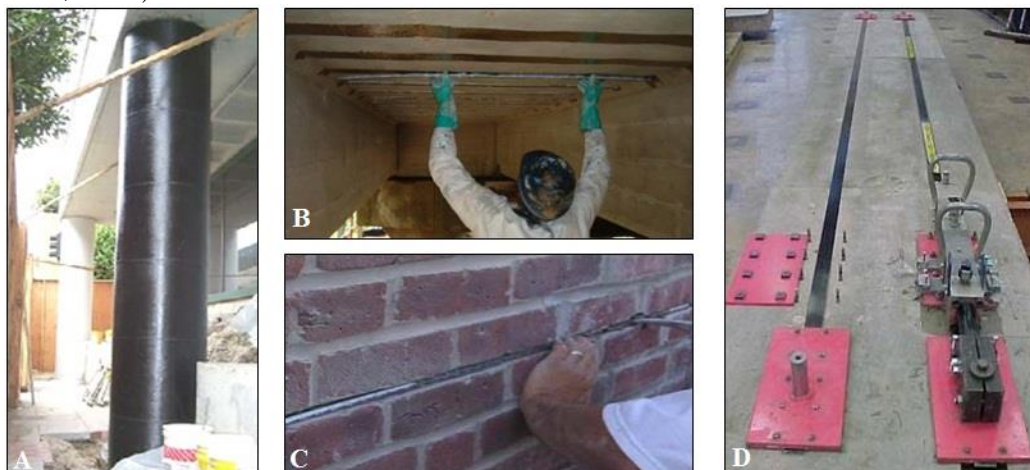
The last two decades of twentieth century have seen the create of composite materials (fiber reinforced polymer or FRP composites) for the strengthening of existing structures (Nanni, 1997; Mayorka and Meguro, 2008; Rashadul, 2008; Nanni, 2012; Augenti et al., 2013; Abdelmegeed, 2015) European countries, in particular Italy has been at the vanguard in the use of the Fiber-Reinforced Polymer (FRP) technology from the practical point of view as well as retrofitting of historical buildings (Augenti et al., 2013). FRP applications include externally bonded fiber plates/sheets installed and adhesively bonded to masonry architectural elements. FRP can install both manually by means manual lay-up and pultruded FRP sheets, adhesively bonded. The first method can produce shear and flexural strengthening to masonry elements besides column confinement (Figure 26a), whereas the last mentioned method is primarily used for flexural strengthening (Figure 26b) (Mayorka and Meguro 2008, Augenti et al., 2012; Nanni, 2012; Augenti et al., 2013).

Figure 26. *Installation Techniques of Fiber-reinforced Polymer (FRP): (a) Manual Lay-up of FRP (Column Confinement) (b) Bonded Plate for Flexural Upgrade (c) Individual Bar in Jointed Mortar (d) Plate/Sheet Pre-tensioning System (Augenti et al., 2013)*
