**ATINER's Conference Paper Series  
ENV2018-2552**

**Study of Erosion Control Techniques Applied to  
Hydroelectric Power Plants Reservoir Margins**

This paper aims to provide relevant information on erosion control processes at water reservoir margins under tropical conditions. This large-scale streambank erosion control study is located on the margins of the water reservoir at Volta Grande Hydroelectric Power Plant in Brazil. This reservoir lake occupies an area of 220 km<sup>2</sup>, and is located in the border of the states of Minas Gerais and São Paulo. Three experimental sites, with fast bank retreat, were identified for the implementation of these erosion control works: Pier (2,700 m<sup>2</sup>), Baia (3,524 m<sup>2</sup>), and Miguelópolis (1,280 m<sup>2</sup>), in a total study area of 7,500 m<sup>2</sup> and length of 500 m, around the reservoir lake. Eleven different bioengineering treatment techniques, vegetated and armored techniques, were implemented on 27 parcels on these three study-areas, as follows: Straw logs and Coir logs (biologs); three metallic gabions coated with polymers and PVC- bags, box, and mattress; Polypropylene (PP) P550 geotextile; PP geotextil

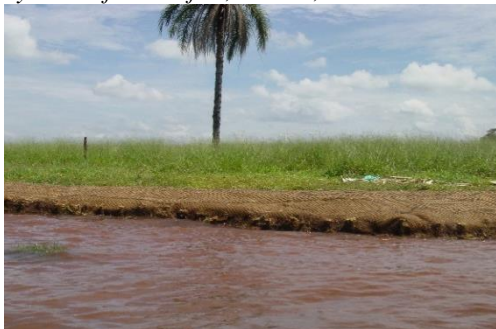
**Figure 1a.** Coconut Fiber Biologs Covered by RECP from Deflor, at Pier, in 2002

Figures 1 to 3 depict the implementation of the selected bioengineering treatments, and at after the vegetation growth.

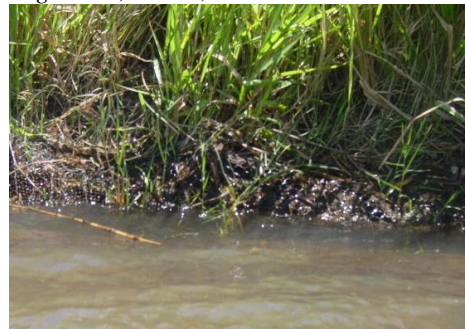
**Figure 1b.** Same Area with Consolidated Vegetation, at Pier, in 2007

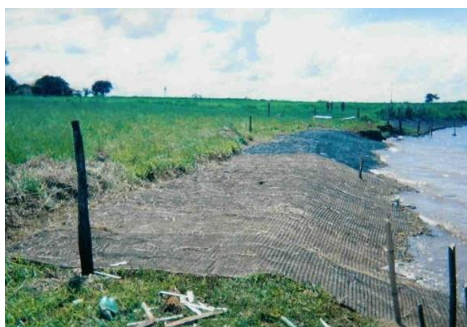
**Figure 2a.** C350 from NAG/USA in 2002

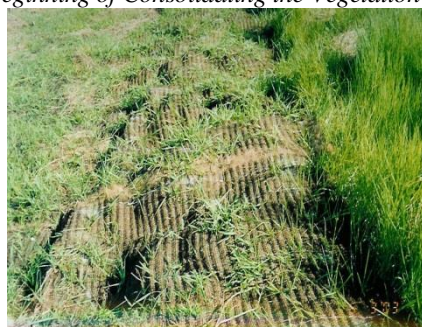
**Figure 2b.** C350 from NAG/USA at Beginning of Consolidating the Vegetation

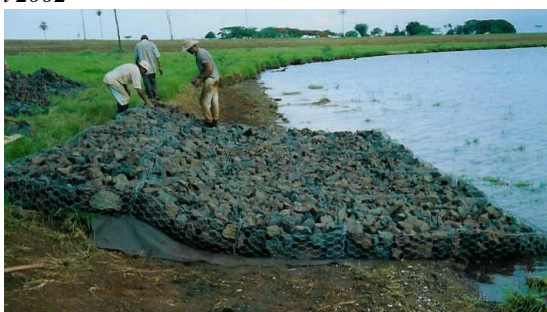
**Figure 3a.** Implementation of Gabion Mattress in 2002

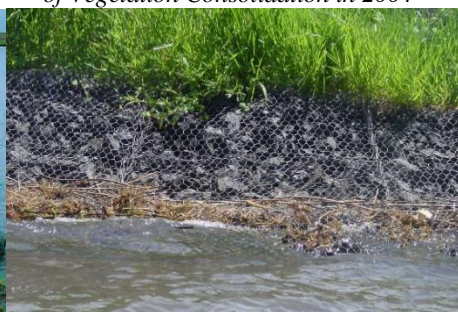
**Figure 3b.** Gabion Mattress at Beginning of Vegetation Consolidation in 2004

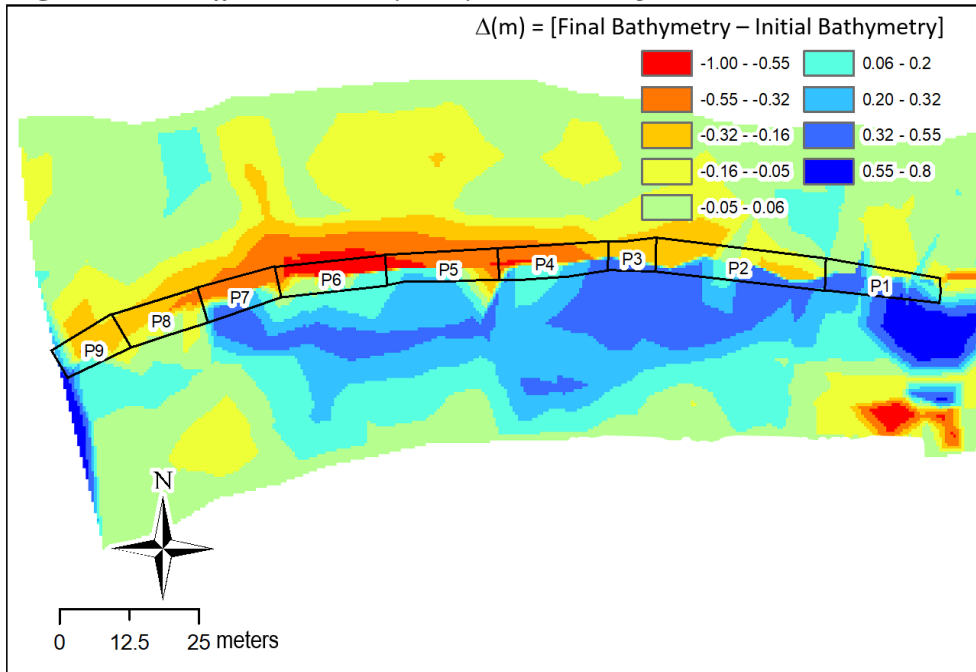
**Figure 4.** *The Differential Bathymetry Plotted Using ArcGIS*

Figure 4 – Differential Bathymetry plotted using ArcGis, in where P1 – vegetated biolgs (filled with straw) + Sintemax geotextile from Deflor Bioengineering/Brazil; P2 – rip-rap; P3- rip-rip + bag Gabion; P4- MacMat geotextile from Maccaferri/Brazil + bag Gabion; P5- rip-rap + Gabion mattress; P6 – Gabion mattress + MacMat geotextile from Maccaferri/Brasil; P7 – rip rap; P8- geotextil P550 from North American Green/USA; P9 - geotextil C350 from North American Green/USA.

It was decided then to use differential bathymetry (final bathymetry – initial bathymetry) developed using in ArcGIS map algebra, to identify soil loss/accumulation in front of each treatment (Figure 4).

According to this differential bathymetry the treatments with less soil deposition in front of them were as follows: P6, P8, P9, and P5. Table 2 shows the summary of the best treatment performance according to differential bathymetry and matrix of performance.
