**Structural Specifications of Turkish
Bath's and Collapse Analysis Scenario of
Ismail Bey Bath, Iznik-Turkey**

**Kerimcan Apak
PhD Student
Polytechnic University of Milan
Italy**

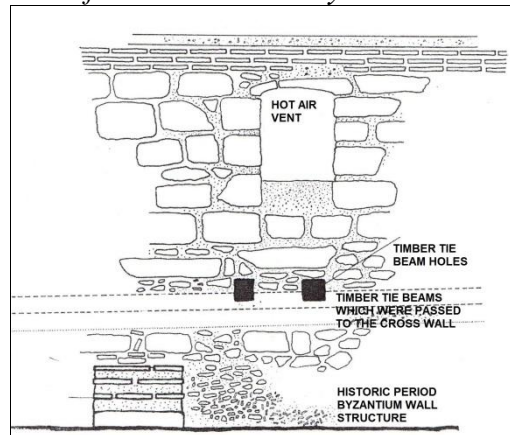
Stone masonry walls were connected to each other with a timber tie beam connection system which was located 20 to 70cm vertically apart from the foundation level. These timber tie beams decomposed in time and in the tie beam holes, pine resin was found. This gives us a hint that pine timber material was used as tie beam in these structures (Fig 2), [5].

Figure 2. *Cross Section of the Stone Masonry in Tahtakale Bath in İstanbul [5]*

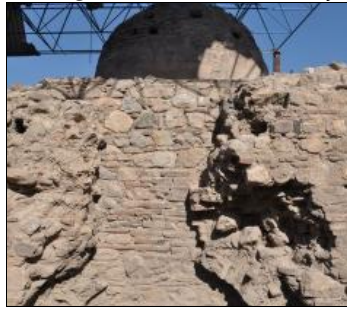
In İsmail Bey Bath, the rectangular plan shape of the structure was built with a rubble stone brick alternative bond (Fig 12). The thickness of the walls was approximately 1m. Walls were three layered; inside of walls rubble stone was used as a filling material (Fig 13, 14), [3, 4, 11, 13].

Figure 12. *Stone Pattern Arrangement in İsmail Bey Bath, İznik*

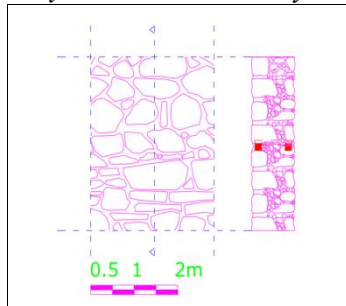
Figure 14. *Section of Masonry Wall in İsmail Bey Bath, İznik*

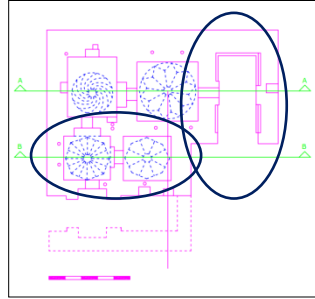
Figure 16. *Plan of İsmail Bey Bath, İznik*

Crack patterns and collapses were diffused in the İsmail Bey Bath structure. Seismic activity or deterioration of the environment could be the reason of these damages (Table 1). In İsmail Bey Bath part of the structure, two domes and one vault were collapsed (Fig 16). Half of the masonry walls of this

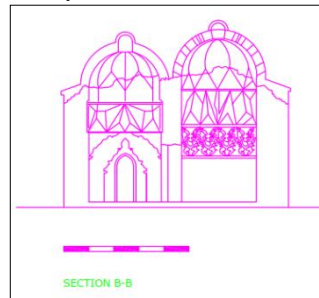
Figure 18. *Section of İsmail Bey Bath, İznik*
