**A Study on Ankara Citadel Area**

In this paper, a study on Ankara citadel area has been performed. Ankara has a special value in the modern State of The Republic of Turkey due to being the capital city of the country. Thereby, Ankara citadel area is a distinctive place which shapes the structural development of Turkey's capital city, which it is also a situation that the structural development of Ankara as the capital city acts as a role model for the other cities of the modern Republic established after Ottoman Empire. Therefore, due to the fact that the special historical significance which Ankara and its citadel area have is the main reason for the selection of Ankara citadel area as a study area. In this regard, a specific public square on the citadel area and the structures existing on the square examined considering public square, structures and relationship between them separately. While examining the study area, the usage relationships of the public square and the structures were evaluated. Additionally, the indoor parts of the some structures were also examined. While doing this, the situations of the study area in the year 2010 and the year 2014 are compared considerin

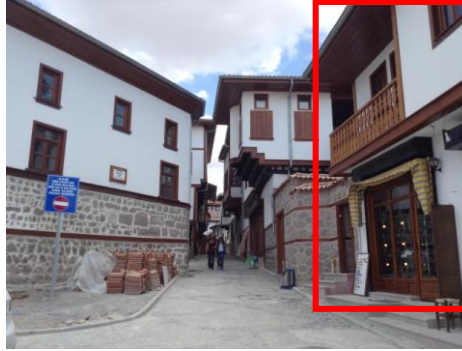
**Figure 10.** *Images from the 4<sup>th</sup> Case (2014)*

In this case, it is seen that this structure consists of two storeys (Figure 9.). The ground floor consists two commercial units one of them is not used and the other ones is used as a shop that contain touristic stuff. The second floor is not used for either commercial or residential purposes. This building seems have no authentic and historical value even if it was in the previous ten years. Because its surface is seemed to be deteriorated (and re-painted, the original material is not realized beneath it), its windows are not authentic representing the modern understanding of architectural aspects. It could be stated that it lost completely its authenticity and historicity. In the Figure 10., the current view of the structure is seen. Within the restoration process, it is observed that the structure was liken to the other structures in the studied square.

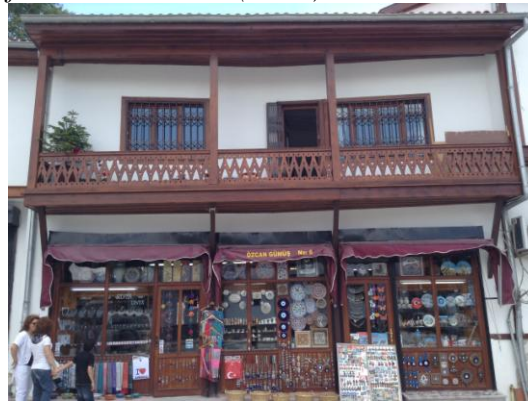
**Figure 12.** Images from the 5<sup>th</sup> Case (2014)

In this case, the structure has two storeys (Figure 11.). The left-ground floor is used for commercial purposes and rest of them of the structure is used for the residential purposes by a family. This structure has considerable authentic and historical importance, considering the material used for its facades, its windows, doors and the ornaments and characteristics of its interior design. In the 1<sup>st</sup> photograph, the colonnade that is indicated with the arrow is seemed to be added later for the fortification yet depending on its authentic characteristics. According to the households of this structure, the balcony and this colonnade built later. In addition to these, the main door of the structure (in photograph 2) is later painted but its original characteristics are protected, so it's an authentic part. Additionally, coming to the interior parts of the building (photographs 3,4 and 5), the ornament and its indent part which the refrigerator put in this example constitute an authentic and historic environment. Additionally,

the steps showed by red arrow in the photograph 4 are also in its original characteristics but it is later varnished and painted. Moreover, window grate in the 5<sup>th</sup> photograph is also original, that is authentic and seems highly historical. In the inner part of the structure which a family lives in, the floor and the ceiling has undergone the repair but depending on its original characteristics considering the material and shape which are used for their construction. In Figure 12., the current situation of the structure is seen. As in the other examples, single type of restoration features have been implemented considering this structure, too. It could be observed that the left-top side of the façade has lost its originality.

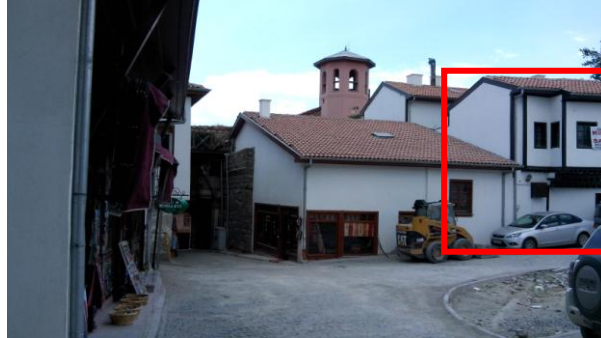
**Figure 18.** Images from the 8<sup>th</sup> Case (2014)

This two-storey house has no commercial activities like in the previous examples (Figure 17.). Instead it is now empty and on hire. Looking at the facades of this building, one can easily realize that it is highly authentic. Its doors and windows have been restored depending on its original characteristics. Its painting and polishment have been properly made in order to protect the structure's own aesthetical, historical and authentional aspects. Especially its colonnade shows the elements of its authenticity. Looking at the 2<sup>nd</sup> photograph, there is a small part has been laterly added is realized immediately. This part is used for the storage purposes. On the other hand, again in the 2<sup>nd</sup> photograph, it can be seen that there are steps. These steps have been laterly added to the structure. In the Figure 18., the current situation of the structure is seen. It is realized that the current restoration process have not had a significant effect in the change of the façade. Only some fixes and the change of color is observed on it.

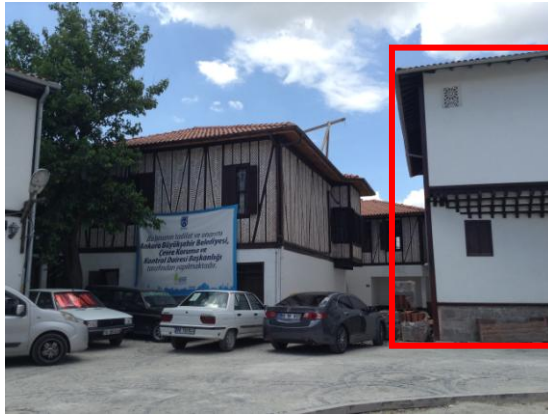
**Figure 22.** Images from the 10<sup>th</sup> Case (2014)

This building is two-storey building and this is another case which could be find authenticity and historicity in the sense of building's materials (Figure 21.). At first glance, this building gives an observer to a kind of authentic and historic sensitivity. The observer can feel inside when he looks at this building. As it could be understood from the photographs that the building has experienced a restoration process. It is seemed that the restoration process has been protected the building's original structure, its authenticity. In the 1<sup>st</sup>

photograph, the colonnade of the building is well protected by the restoration process and as it can be easily seen from the 2<sup>nd</sup> photograph that the door outside of the building is also in its own authenticity means that the original characteristics of the door (materials used in its construction ) has been maintained properly. In addition to these this building was used by Türkiye Foto Muhabirleri Derneği. However, in the previous years, this building has transferred to the municipality and waiting for the operation. In the Figure 22., the current situation of the structure is seen. It is seen from the figure that the current restoration process has contributed to some fixes on the façade.
