**ATINER's Conference Paper Series
ENV2014-1246**

**Environmental Degradation and its
Impact on Water Pollution of Uttar
Kannada District of Karnataka State –
India: A Geographical Approach**

**Ghanshyama Patankar
Associate Professor
Karnataka University
India**

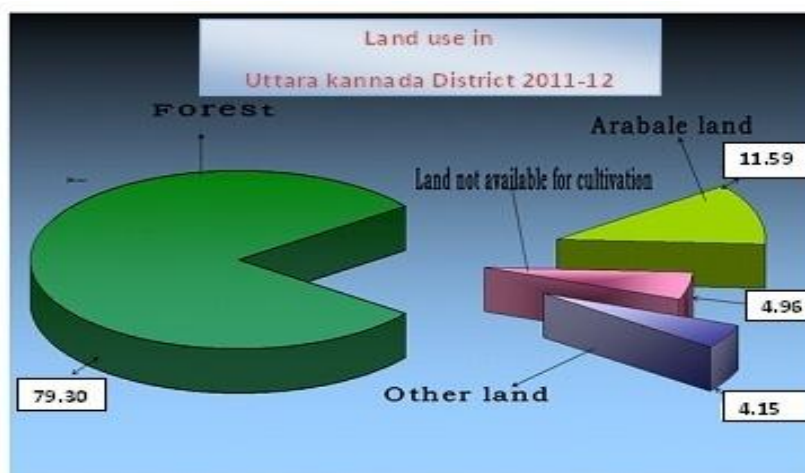
Figure 2.

wet zone is associated with rice, areca nut, coconut and evergreen forest. The moderate zone in the upper ghat region associated with fruit gardening under the influence of soil and climate. Forest land occupies 79.30 per cent of the district area (Figure 2).

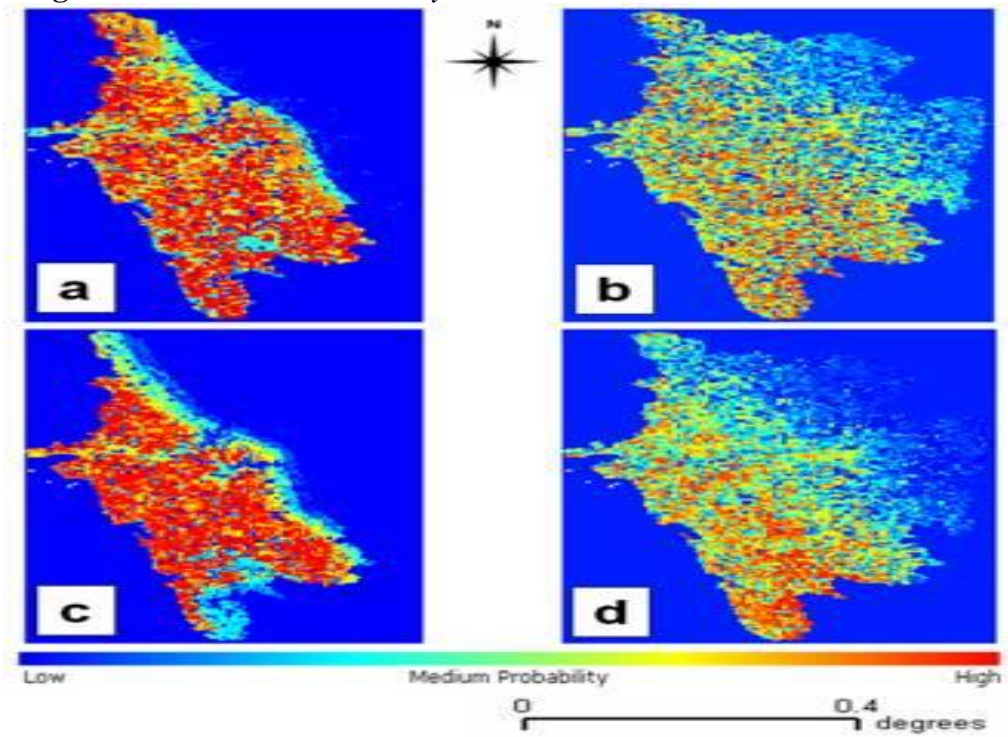
Figure 3. *Land Slide Probability Zone*

The execution of projects, urban construction, unscientific hill cutting on the weaker zones for the construction of transport lines, village and private roads, the activity of quarrying, pediment cutting, soil removal and stripping of vegetation increases risk and posing wide spread and frequent landslide problems. The new surface exposed to heavy rainfall and the steep terrain support the removal of soil and adds much silt and turbidity in *water bodies* (Figure 3)

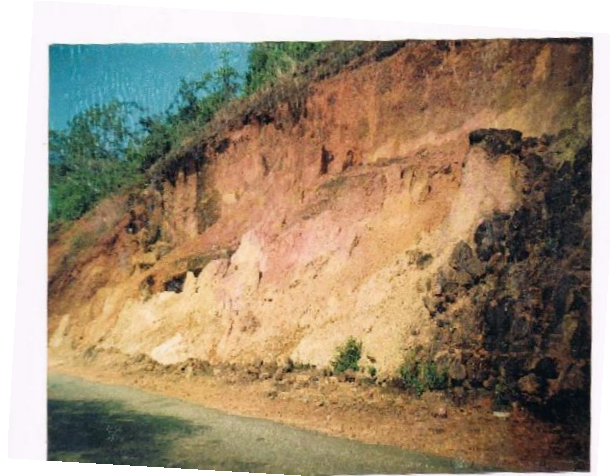
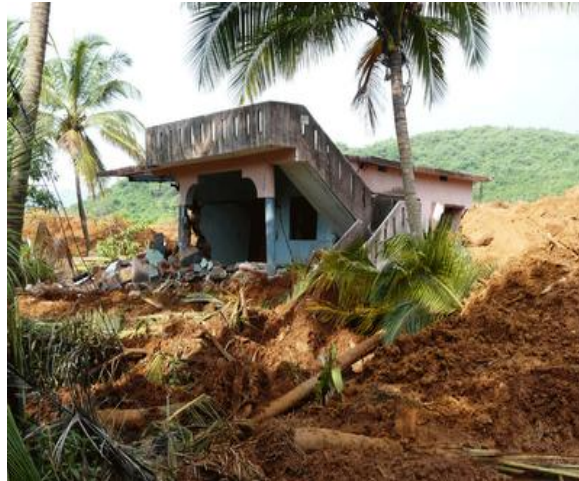
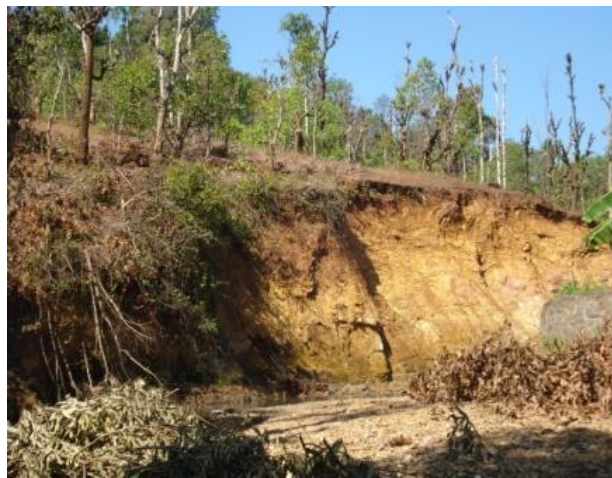
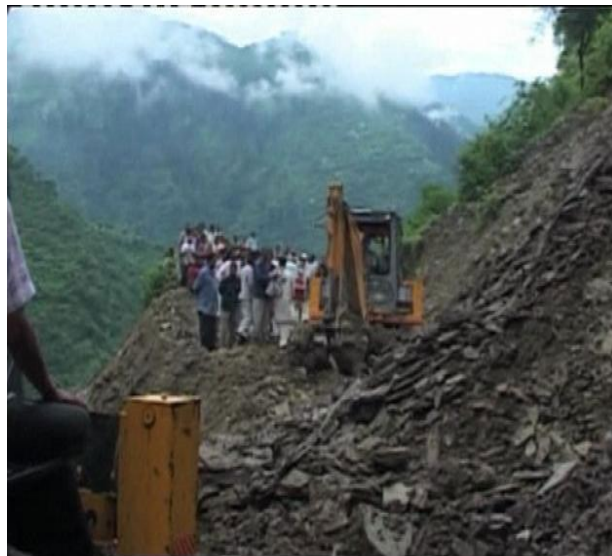
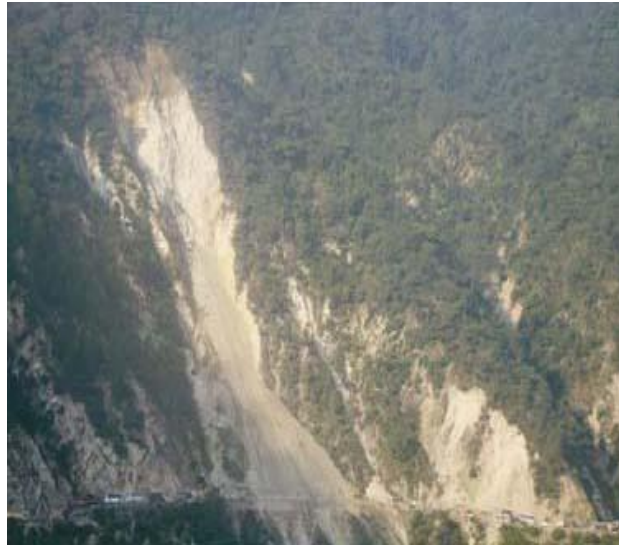
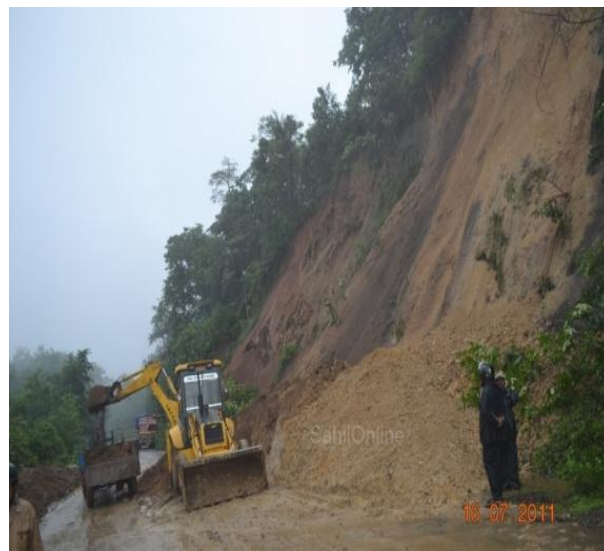
Photo 1. *Land Slides and Newly Exposed Surface to Erosion*

The proneness of the region to landslides has increased in the recent past due to raising human impact on forest. The degraded and barren hill slope, the river valley sides, the type and structure of soil, the loose and embedded laterite boulders in the clayey soil become sensitive and develops slippery surface during s-w monsoon which exert pressure and slides on hill slope. The rotten tree root opening acts as capillaries raises water in the openings and soak up the soft soils in the interior triggering mudslides due to rupture of the hills (Photo 1)

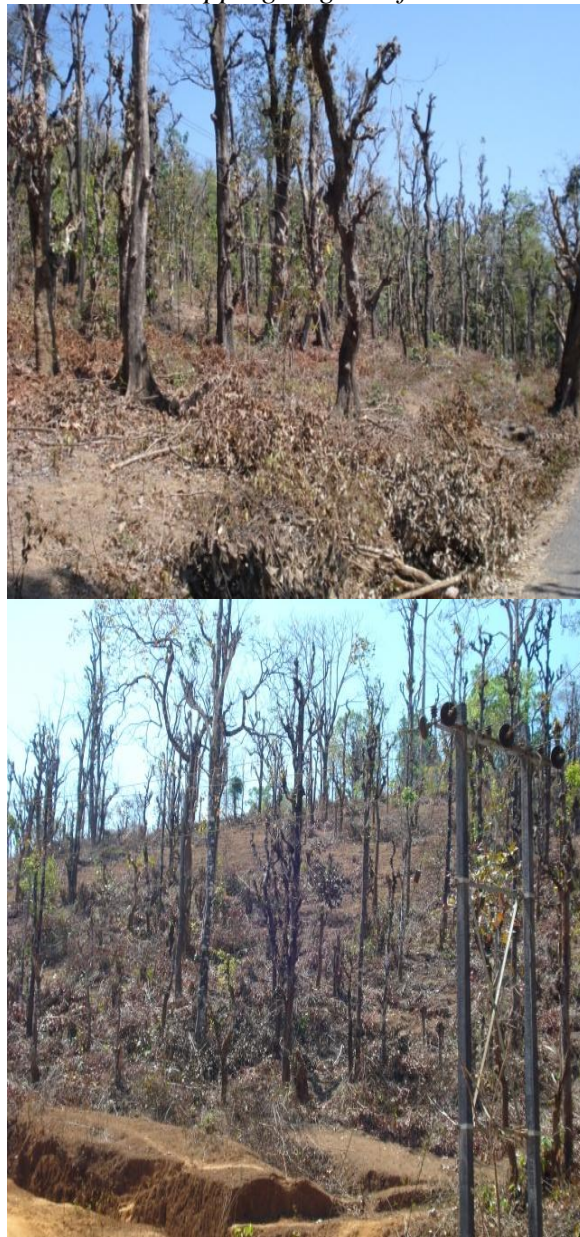
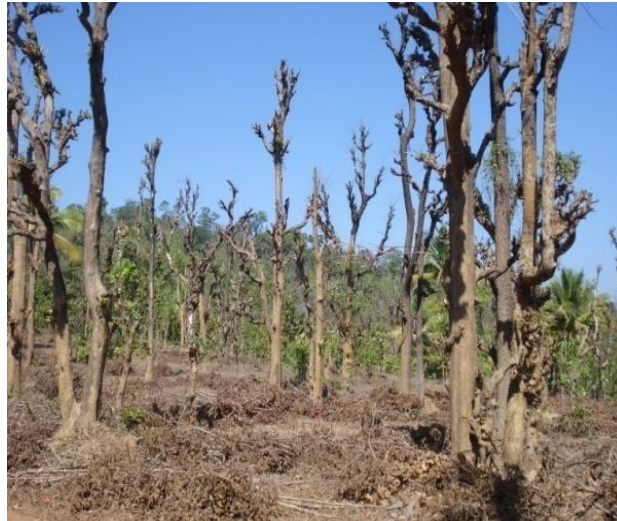
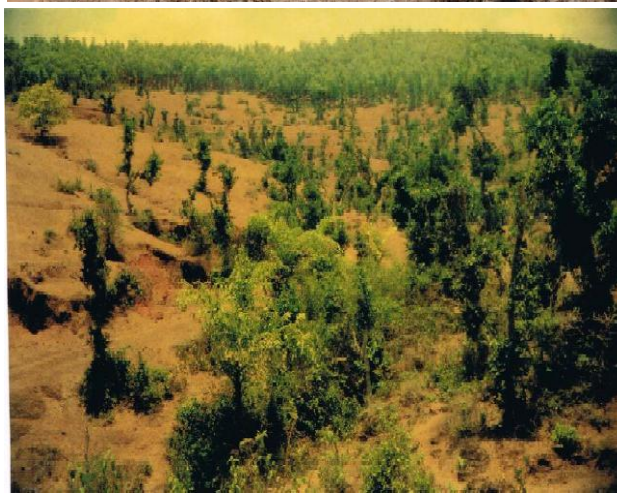
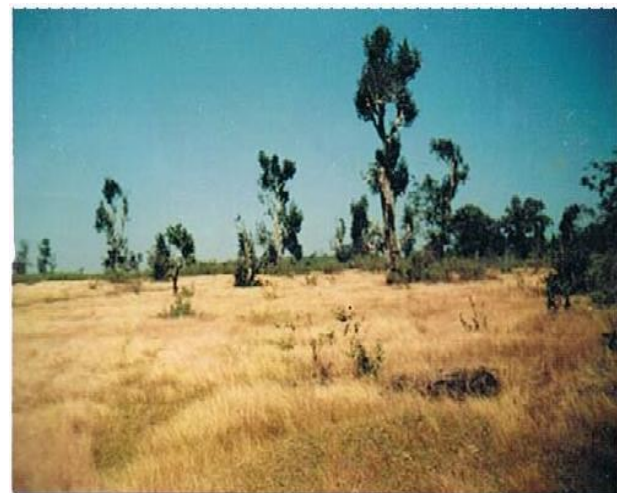
Photo 2. *Degraded Evergreen Forest Due to Cutting of Green Twigs for Manure in the Horticultural Cropping Region of the District*

It is a major threat to forest density in the coastal and Malnad region of the district where hill gaps and valley plains are utilized for plantation crops like coconut, arecanut, banana and other mixed crops like cardamom, pepper etc. Their dependency on green manure to maintain fertility and moisture in the soil destroys considerable forest around these cropping regions. The severe cutting of green twigs and undergrowth keep the barren surface easy ground for soil erosion and impact on water pollution in the lower streams (Photo 2).

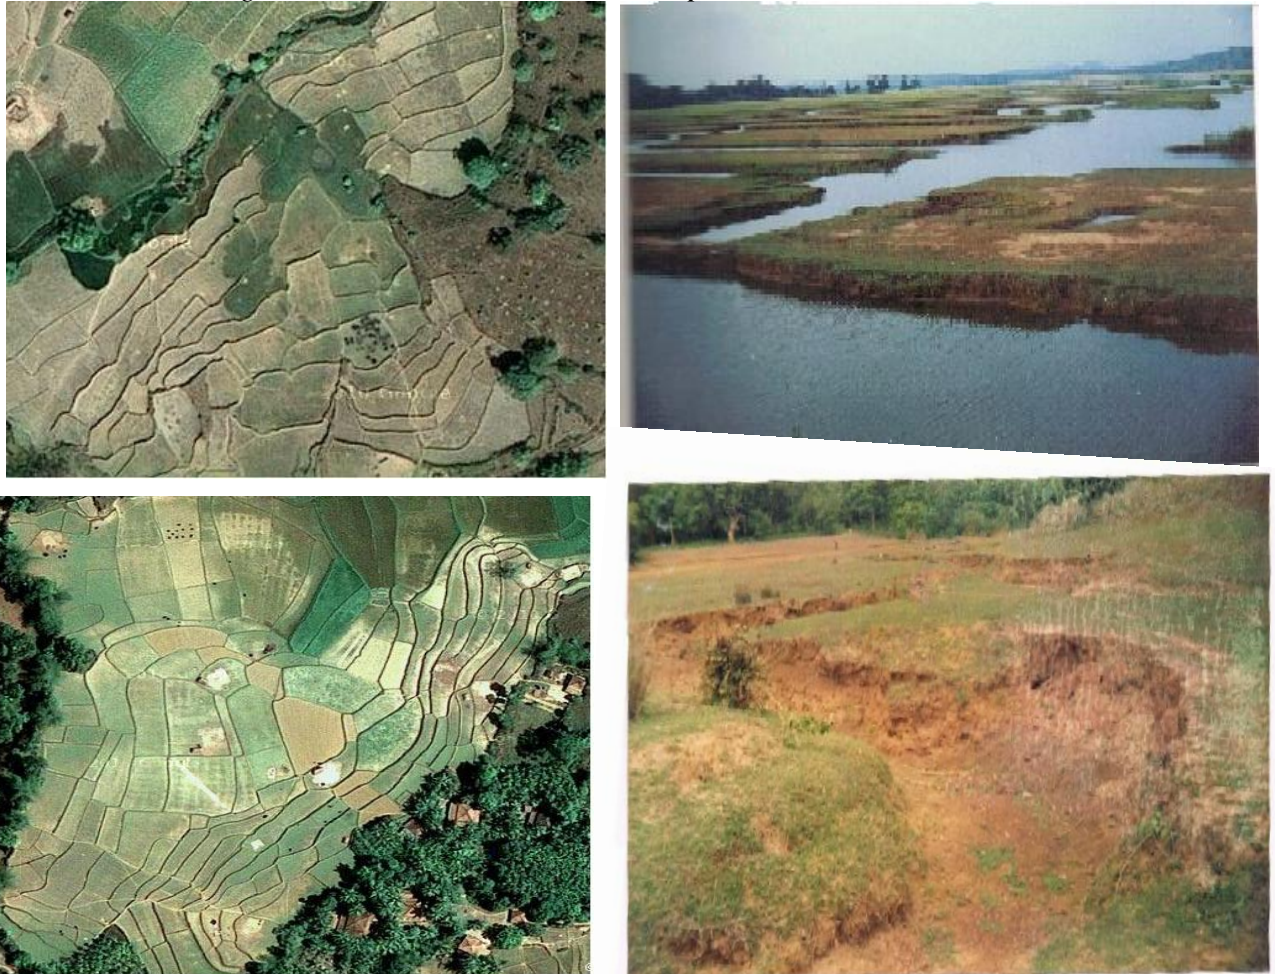
Photo 3. *Mismanaged Bunds and Soil Erosion in Crop Land*

The traditional method of paddy cultivation is practiced in all the three sub-regions. The hill slope terraces, mismanaged bunds, heavy rainfall leads to swift flow of over flooded water which carries large quantities of soluble particles. The higher cattle density provides large quantity of dung and cutting of huge quantities of green twigs for manure. It degrades forest which support soil erosion and reduce fertility status and crop yield. It carries large quantity of silt, turbid water and biotic materials in to nearby tanks and river courses (Photo 3).

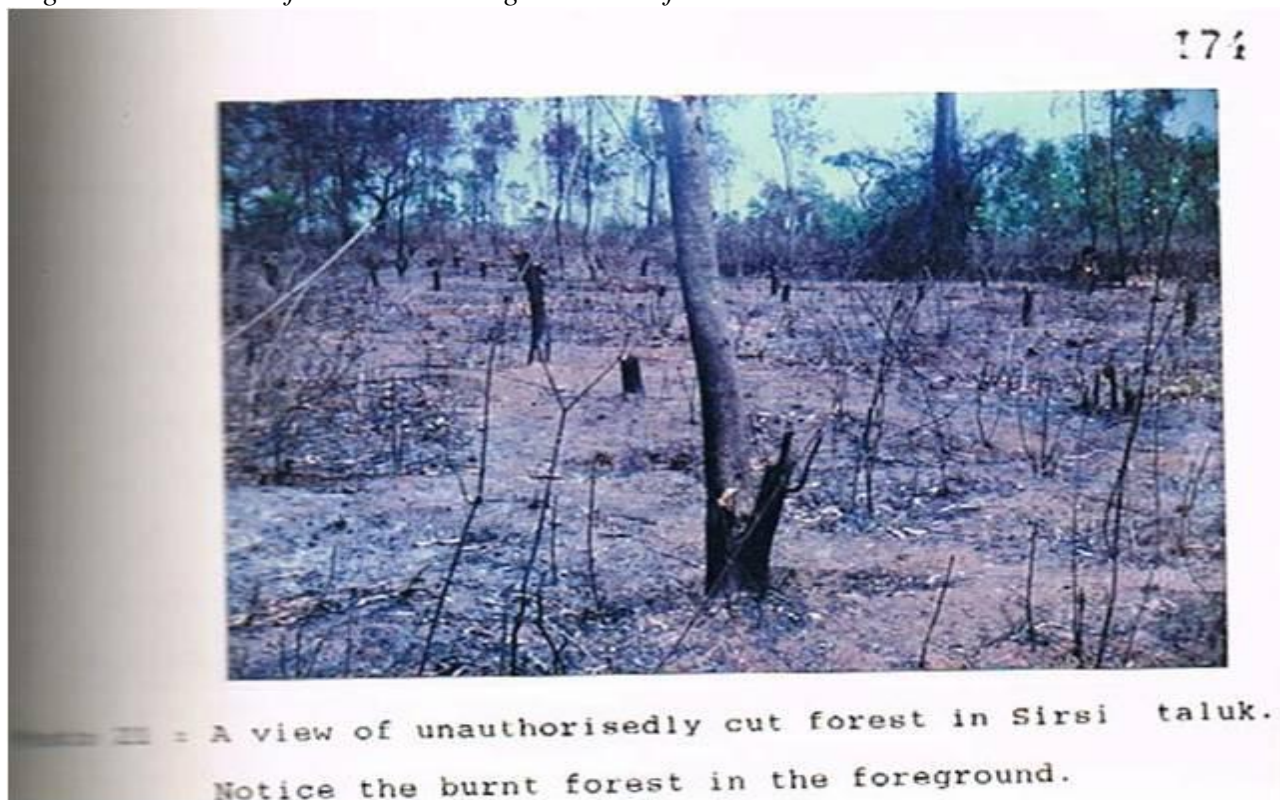
Photo 4. *The Burnt Undergrowth Keeps the Soil Surface Open to Rain and Degrades the Soil Surface Until the Regeneration of Fresh Grass and Bushes.*

Fire incidence is more common in all the sub-regions. But it is more deadly in the deciduous belt of semi-malnad. The dried up grass, undergrowth, shaded leaves and other vegetative matter are more sensitive to fire during dry season. It destroys lower and middle canopy of forest considerably and affect

regeneration. It carries large quantity of vegetative matter into river courses and nearby tanks. Farmer intentionally put fire to grass land and crop residue with an intention to get better crop yield in the next season and also for encroaching the adjacent forest land. (Photo 4). Some time it also spreads to the entire forest and destroys the undergrowth.

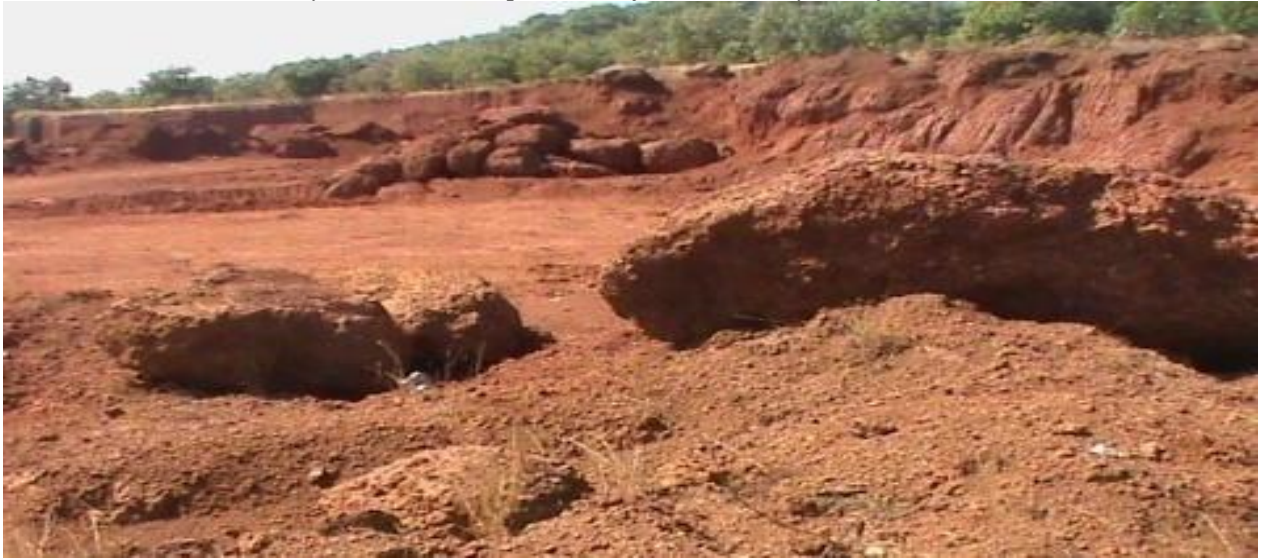
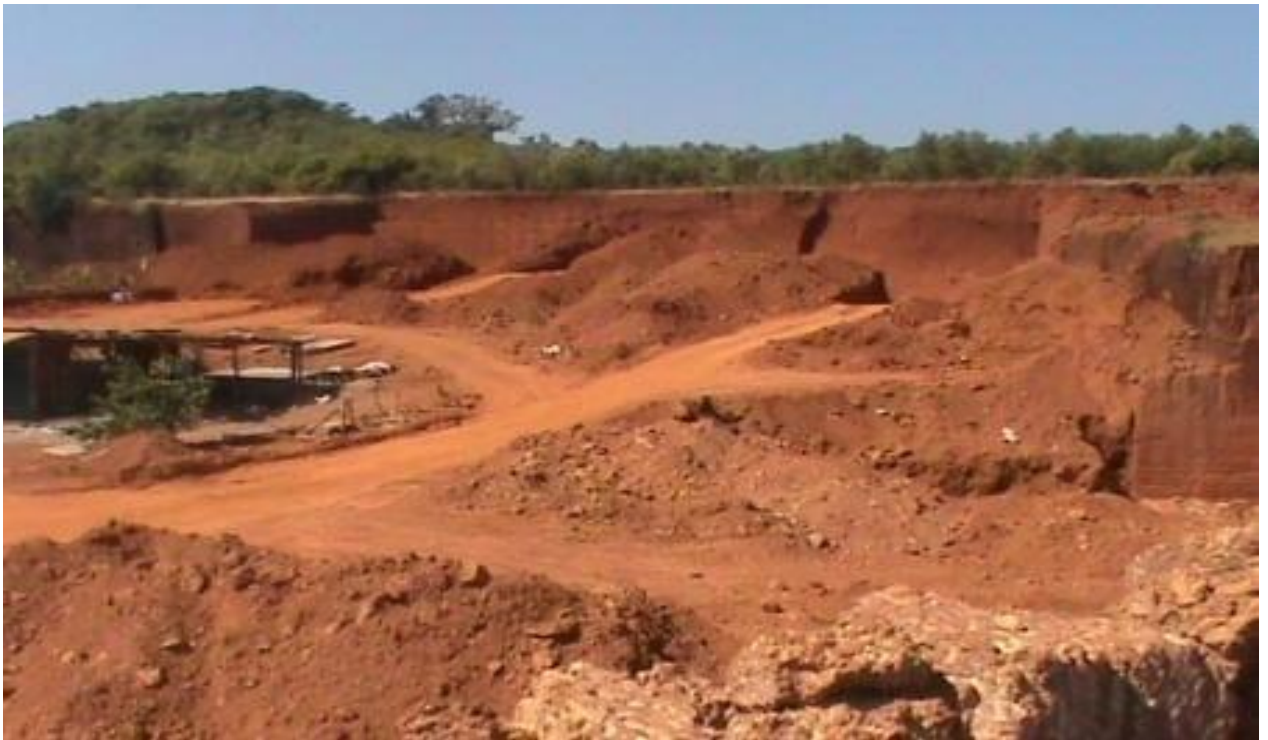
Photo 5. *Laterite Quarry and Loose Exposed Surface to Heavy Rainfall*

The district has rich sources of minerals. But mining activities is stopped to conserve forest and natural environment. Laterite is the main source of building constructional material in the district. Its quarry is widely distributed and severely damaging the surface by exposing new loose surface to heavy rainfall on the steep slopes. The digging of the earth for execution of plans and projects also severely exposes new surface to severe erosion. It degrades the surface and adds silt in the river courses and nearby tanks. (Photo 5)

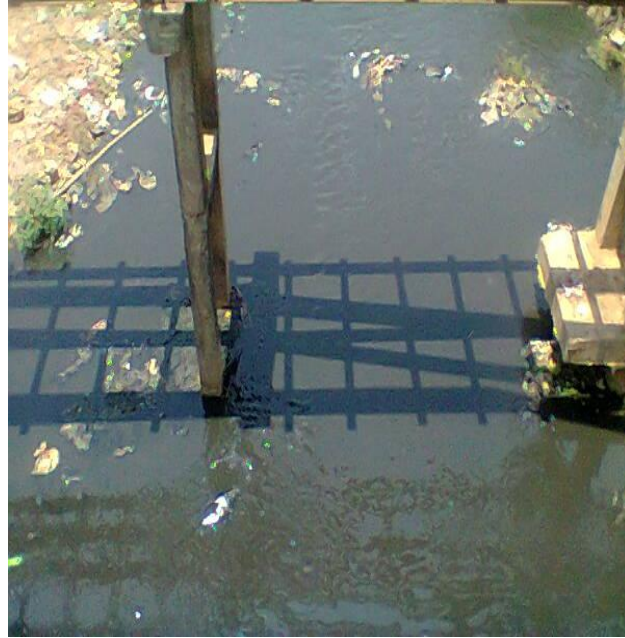
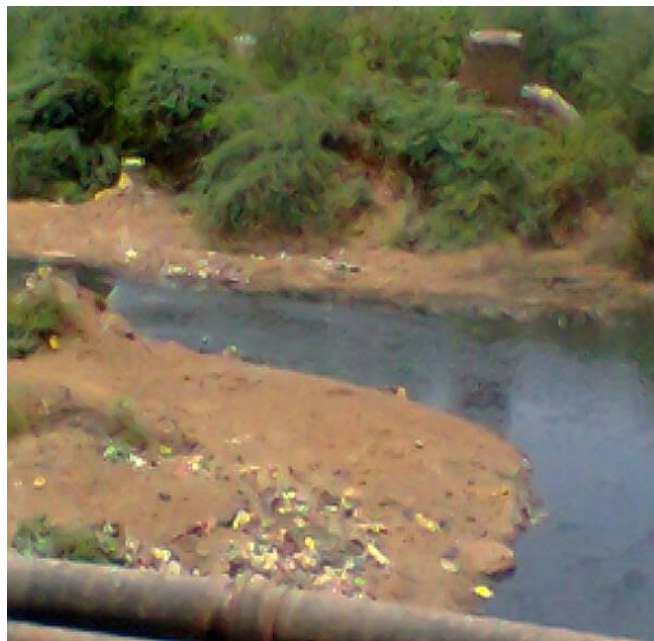
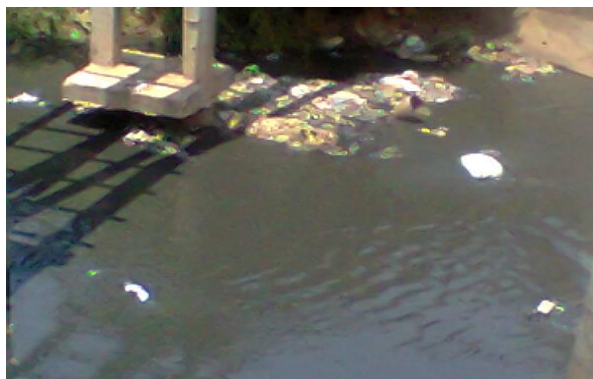
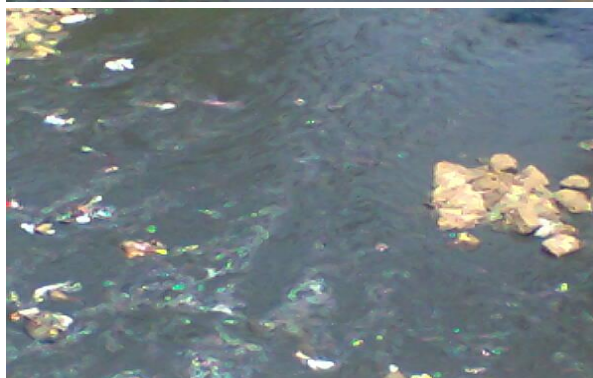
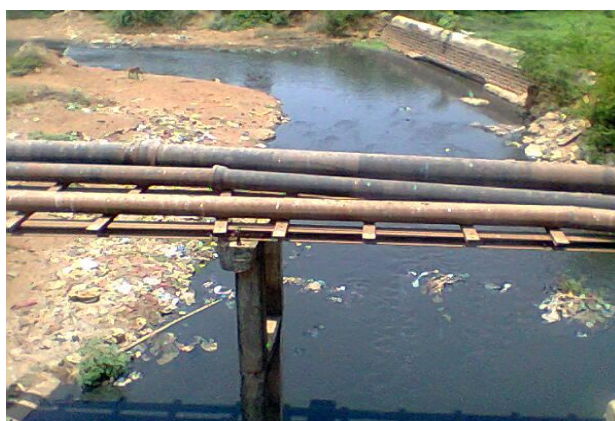
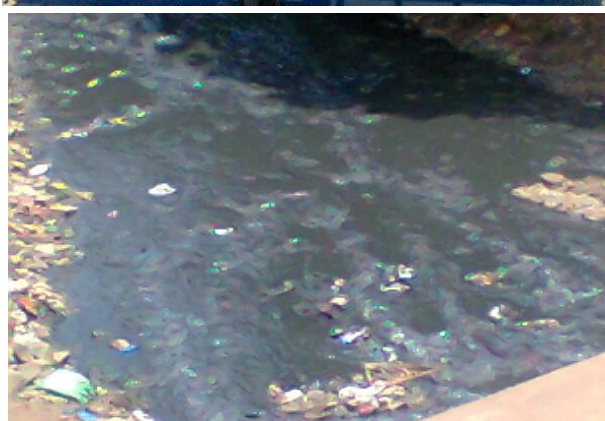
Photo 6. *Untreated Pollutants of Sewage and Industrial Waste of Hubli and Dharwad City Finds its Way to Badti River*

Earlier the thick forest cover of the district kept the natural set up intact. All by-products produced either by man or by nature were re-cycled back into the environment by nature. However with the increased act of man in nature producing overload of pollutants which is allowed to continue and the environment has little chance to self-cleaning today(Photo No.6).

The point source pollutants rarely exist in the district due to lack of large scale industries, except few countable points. A paper industry located on the bank of river Kali at Dandeli releases voluminous untreated effluents. The chemical companies located at its estuary that has been leaking toxic wastes including mercury for a decade. In the upper course of Bedti, water is severely polluted due to discharge of untreated industrial water and released non-point pollutants like urban runoff and sewage released from the commercial center Hubli. The left bank tributary stream adds turbid water and polluted its physical property (Photo No.7).

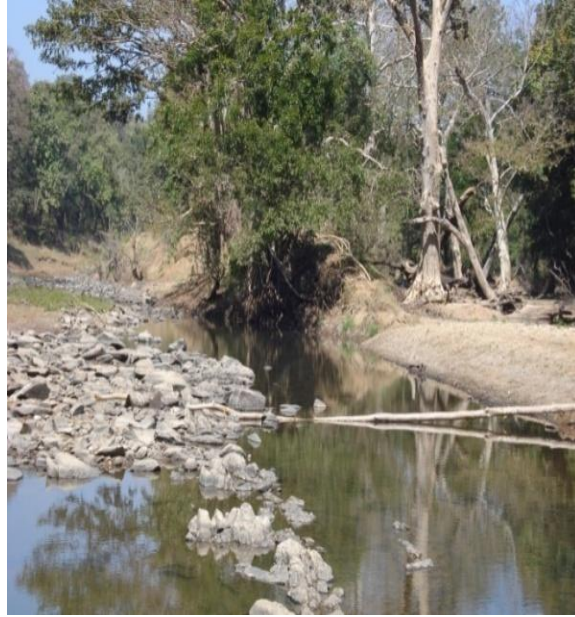
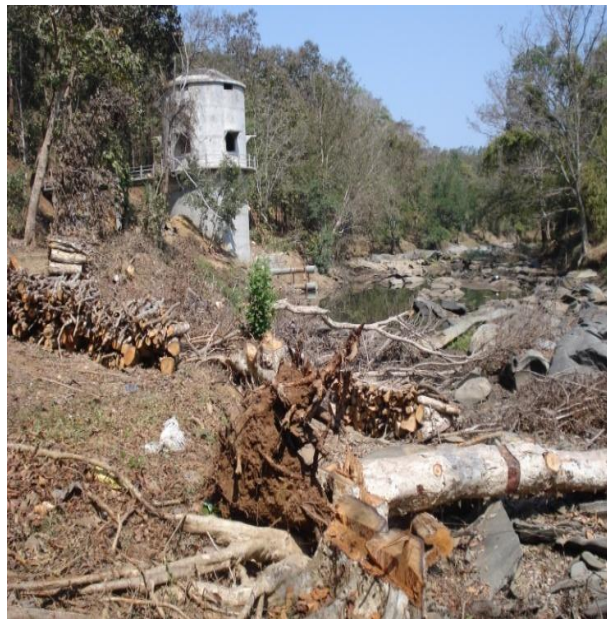
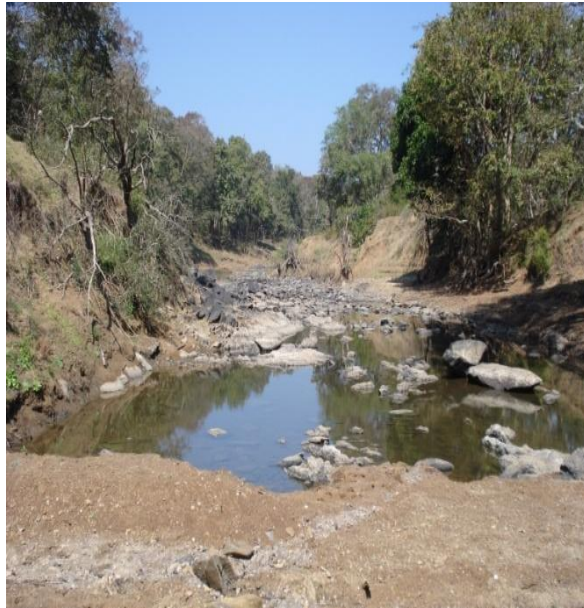
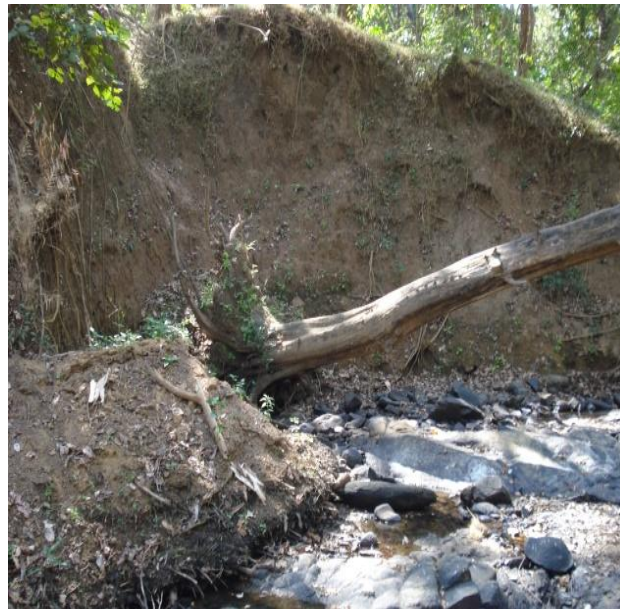
Photo 7. *It Shows the Shallow Tributary Bed Soon after s-w Monsoon Due to Degradation in the Evergreen Forest. The Lateral Erosion and Silting*

The construction of dam for power generation in the upper courses of the river Kali and the Sharavati, dilutes salinity level in the estuary and affects salt water mangroves (Sconeratia), edible bivalve shells and many other creatures have disappeared in estuaries (Photo 7)

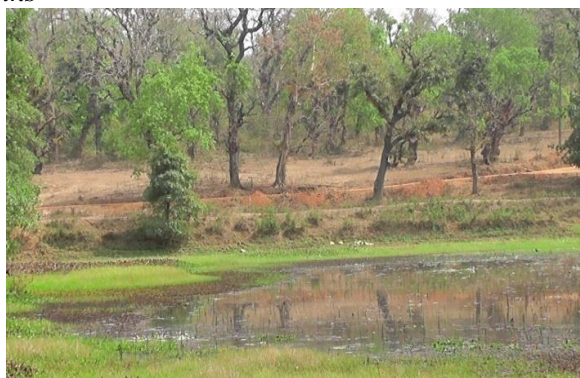
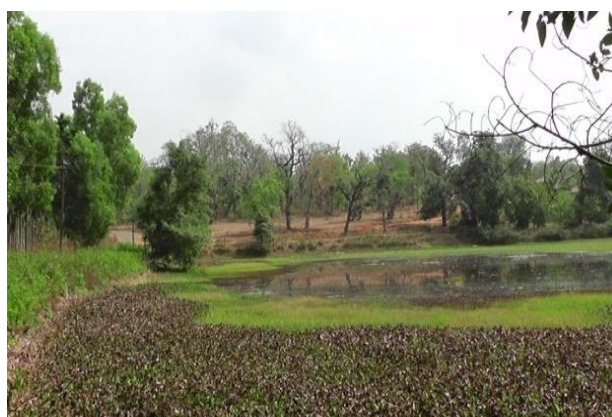
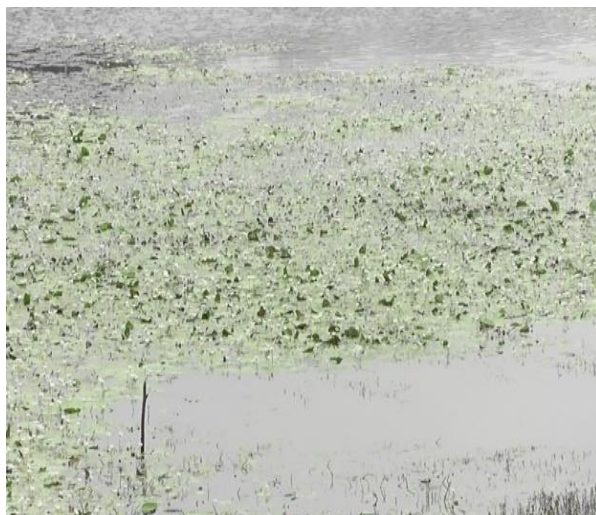
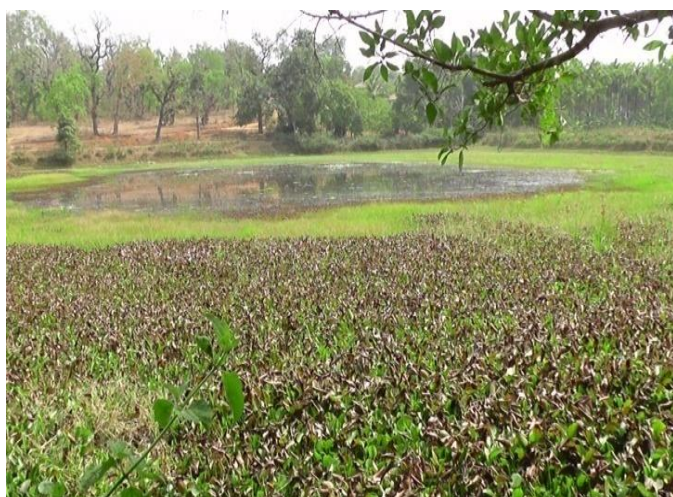
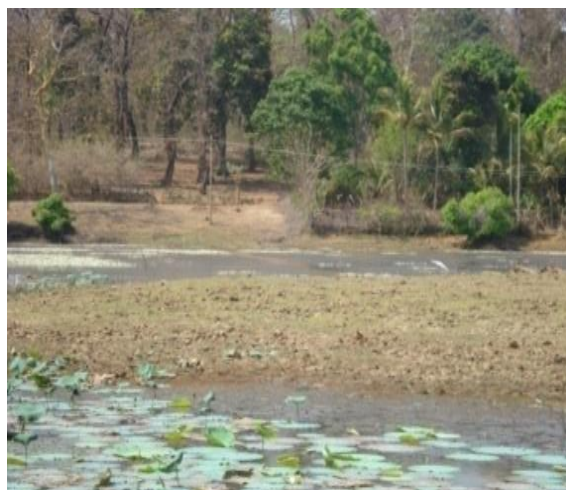
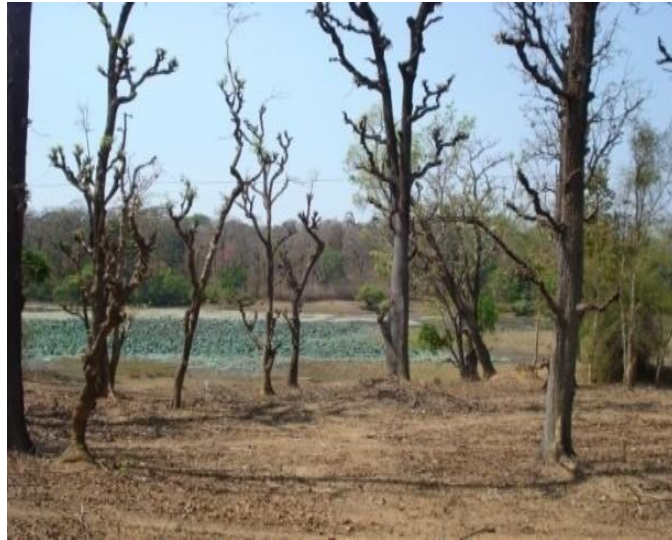
Photo 8. *Uttara Kannada District, the Silting and Growing of Weeds Due to Mismanaged Tanks*

Tanks are the main sources of water for domestic use, cattle strength, inland fishing, local wild life and aquatic eco-system. Earlier the recharge and discharge system was in equilibrium and the quality of water was satisfactory. With the introduction of drinking water schemes most of these tanks are mismanaged at many places. The barren surface affected by sheet and rill erosion on the hill slope finds its way to these tanks. It adds eroded materials and soluble salts, organic matter, nutrients like phosphorus carried from surrounding forest and crop lands. It damages the fresh water eco-systems of tanks. The enriched nutrients stimulated growth of algae in most of the tanks in the district. At Places tanks water turns to deep greenish where the ability of

light to filter through is diminished it can directly affect aquatic plants glade and plankton which reside at the bottom of the food chain. The tanks which are located in the town and nearby are affected by sewage at many places. The cleaning of vehicles adds toxic contaminants in to these tanks. The increased oil and grease film floating is reducing visibility of water (Photos 8 & 9)

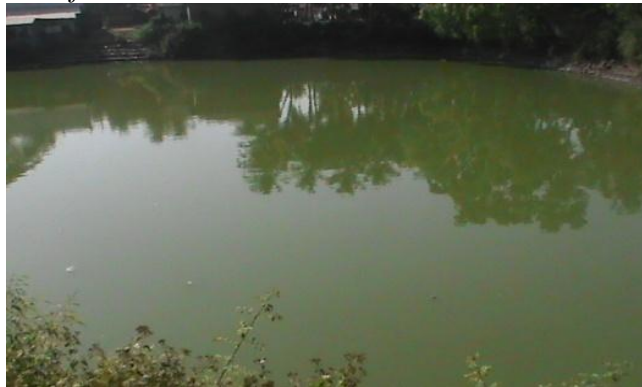
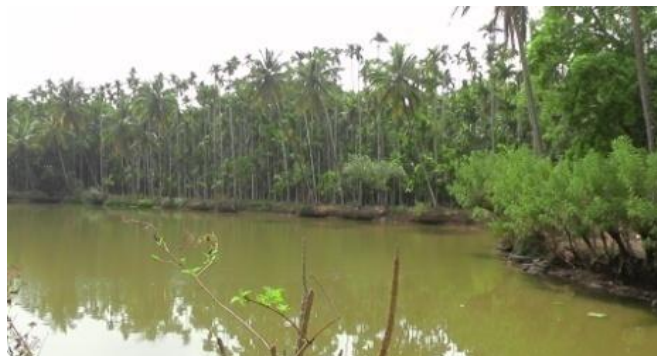
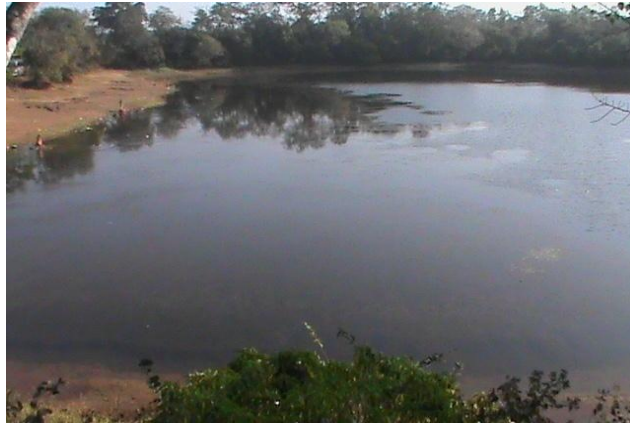
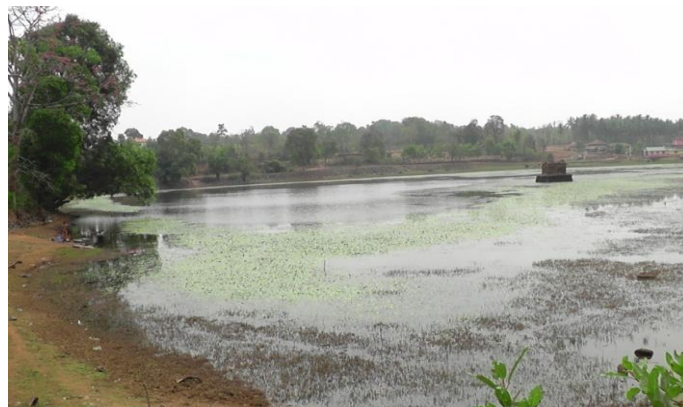
Photo 9. *Polluted Tanks Due to Mixing of Sewage and Other Pollutants in and around the Towns of the District*
